AIR INFILTRATION: THE ENEMY OF *WIND RESISTANCE* AND **CONDENSATION CONTROL**

By Philip Dregger, PE, RRC

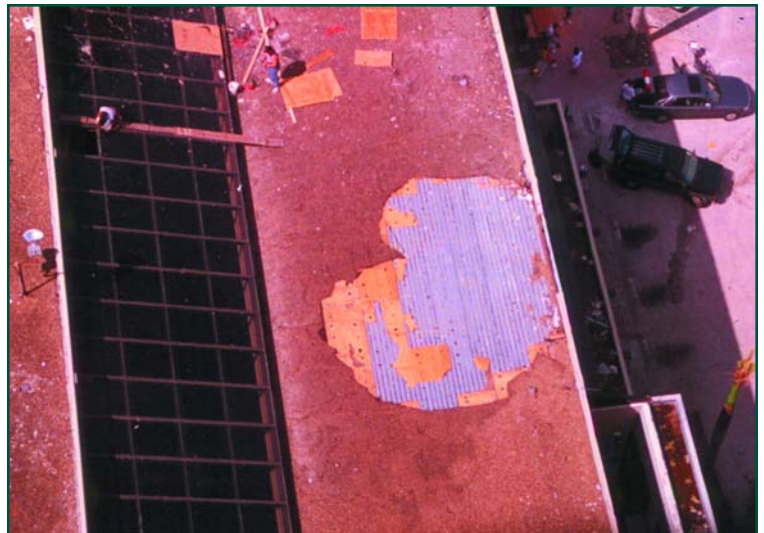
Figure 1 shows a roof damaged by wind speeds well below code levels. Figure 2 shows a roof with condensation-induced deterioration. In both cases, air infiltration played a major role in creating the problem conditions.

Figure 1: Roof damaged by wind speeds well below code levels.

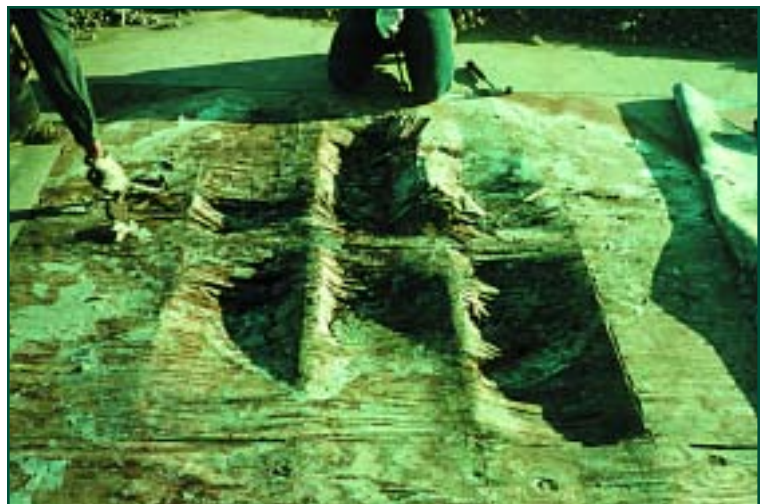
Figure 2: A roof with condensation-induced deterioration.

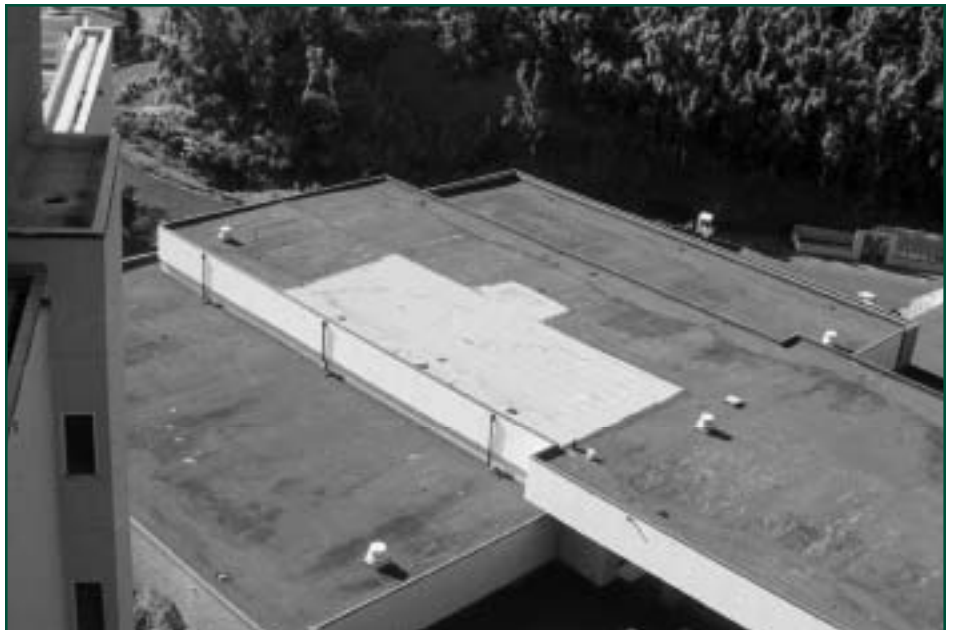
A three-story hotel structure with an aggregate-surfaced built up roof (BUR) over mechanically fastened insulation and a steel deck had wind damage along one side. *Figure 4* shows that the damage started near two roof drains with adjacent through-wall overflow scuppers midway along the windward side of the building. No damage was observed near corners. Observations indicated openings for air infiltration around through-wall overflow scuppers and around drains. Base flashings near overflow scuppers are believed to have lifted and initiated progressive peel fueled by rapid air infiltration around the drains.

Figure 4: Damage initiated near two roof drains with adjacent through-wall overflow scuppers midway along the windward side of the building.

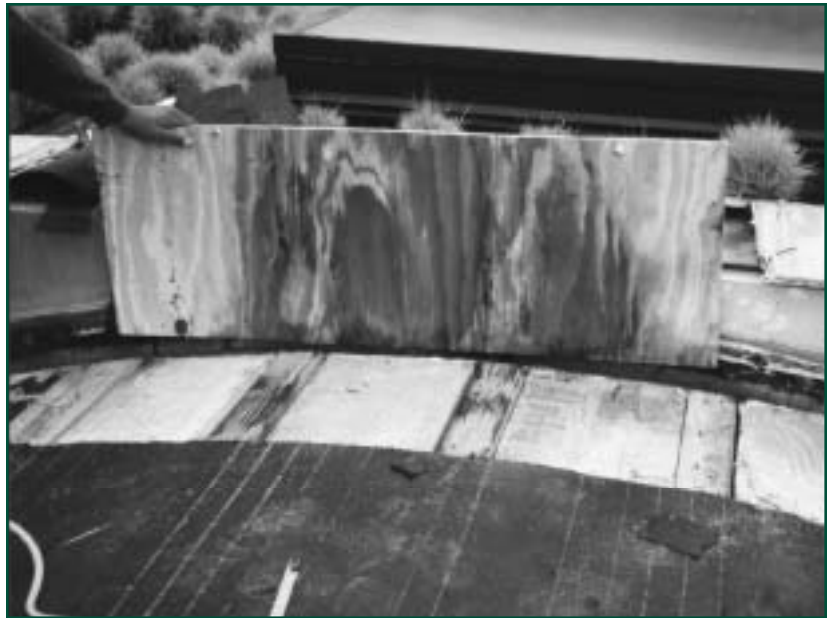
A San Francisco Bay Area Health Club had a swimming pool and a workout/office area separated by a common wall. The swimming pool area walls included a vapor retarder and insulation installed above a sloped plywood deck with a shed-shaped, standing seam metal roof. The adjacent workout/office area had a low-sloped BUR installed over a plywood deck over insulated joist spaces and a suspended ceiling. Advanced deterioration was discovered in the roof deck and framing members over the office/workout areas – primarily adjacent to the common wall. Relative humidity in the office/workout areas ranged from 45% to 60%. Although immediately adjacent to a high humidity area; UBC, NRCA, CRREL, and ORNL guidelines did not indicate the need for a vapor retarder over the office/workout area. ASHRAE type analysis indicated the potential for condensation during winter conditions. Observations indicated openings along the ridge of the metal shed roof allowed large quantities of moisture-laden air to bypass the vapor retarder and flow into the stud spaces of the common wall and then into the plenum area below the low-sloped roof area.

The familiar guidelines did not adequately predict the need for a vapor retarder because the guidelines assume “compact” assemblies with little or no opportunity for the physical transport of water vapor.

Figure 8: Saturated plywood conditions uncovered near tops of barrels.

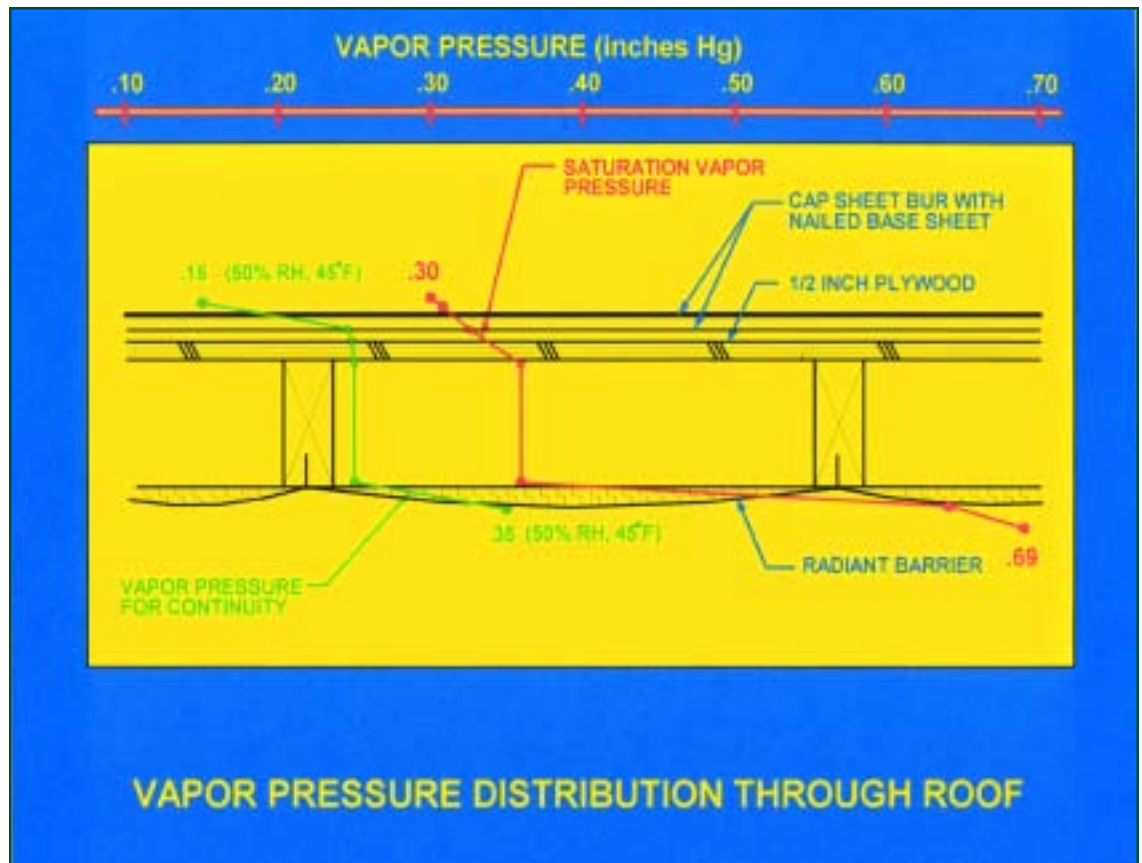
A large Southern California distribution center with a BUR over a panelized plywood deck with a radiant barrier below also experienced condensation-induced deterioration. Occupants were alerted to condensation conditions when corroded joist hangers allowed a purlin to fall to the floor. UBC, NRCA, CRREL, ORNL, and ASHRAE (*Figure 9*) guidelines indicated no need for a vapor retarder. Observations indicated a correlation between deterioration conditions and high points in the deck and near joist spaces with various penetrations. Among other things, the condensation conditions were attributed to convective air movements transporting large amounts of moisture-laden air into areas with surfaces below the dew point of the water vapor. Remedial action by others included replacement of much of the roof deck and cutting back the radiant barrier about 1/2" at each end of each joist space. (See American Institute of Timber Construction Technical Note No. 20, “Guidelines to

Figure 9: UBC, NRCA, CRREL, ORNL, and ASHRAE guidelines indicated no need for a vapor retarder.
