REASONABLE INTENTIONS AND INSTALLATION TEMPERATURES; *A CAUTIONARY TALE*

BY JEFF CRAMER, RRC

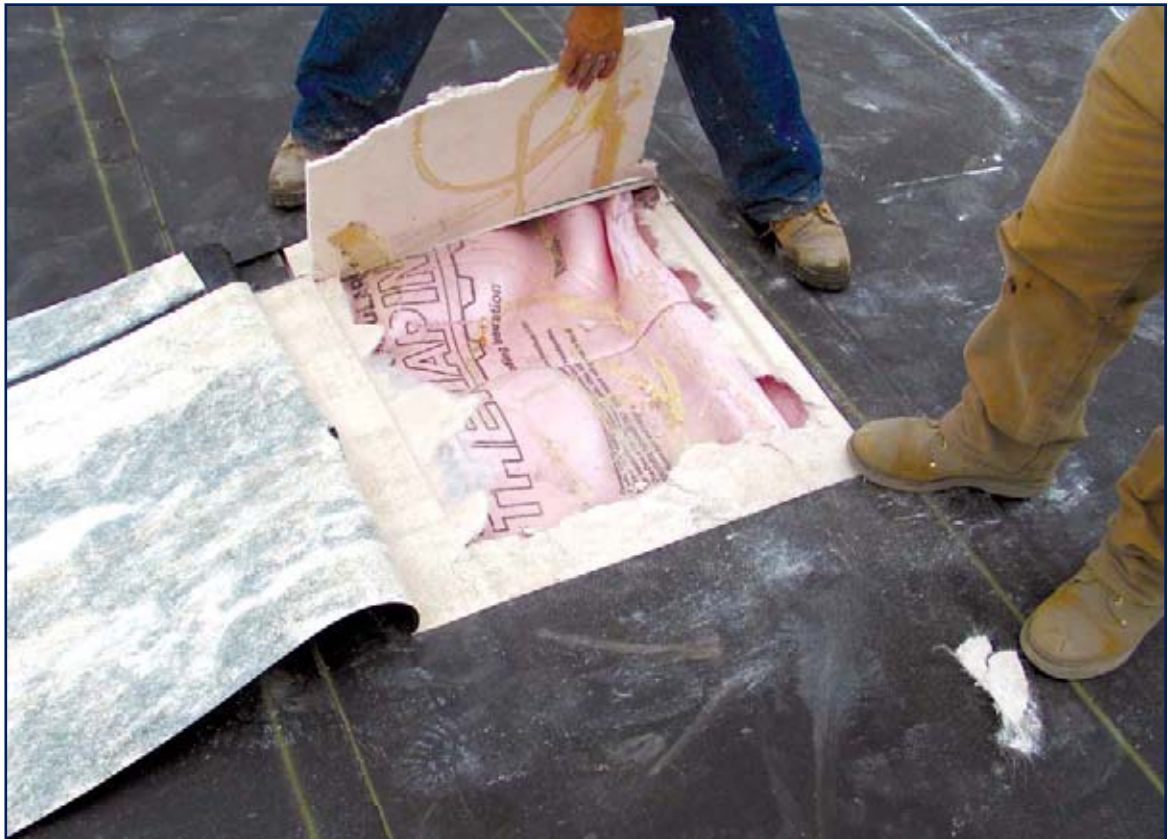
Wrinkling and curling in the EXPS-tapered roof insulation below the 1/2-inch, glass-faced gypsum coverboard.

The only variable was the black polyethylene sheeting laid over the roof to keep its surface moisture-free. This appears to have prevented the dispersion of solar-generated heat, and thus, allowed the tapered insulation to reach temperatures in excess of the recommended service temperature.

like a good idea, but the side effect of trapping solar-generated heat can be disastrous. It is always a good idea to pay attention to the temperature limitations of products that are part of the design; one never knows when they will become important to the system.

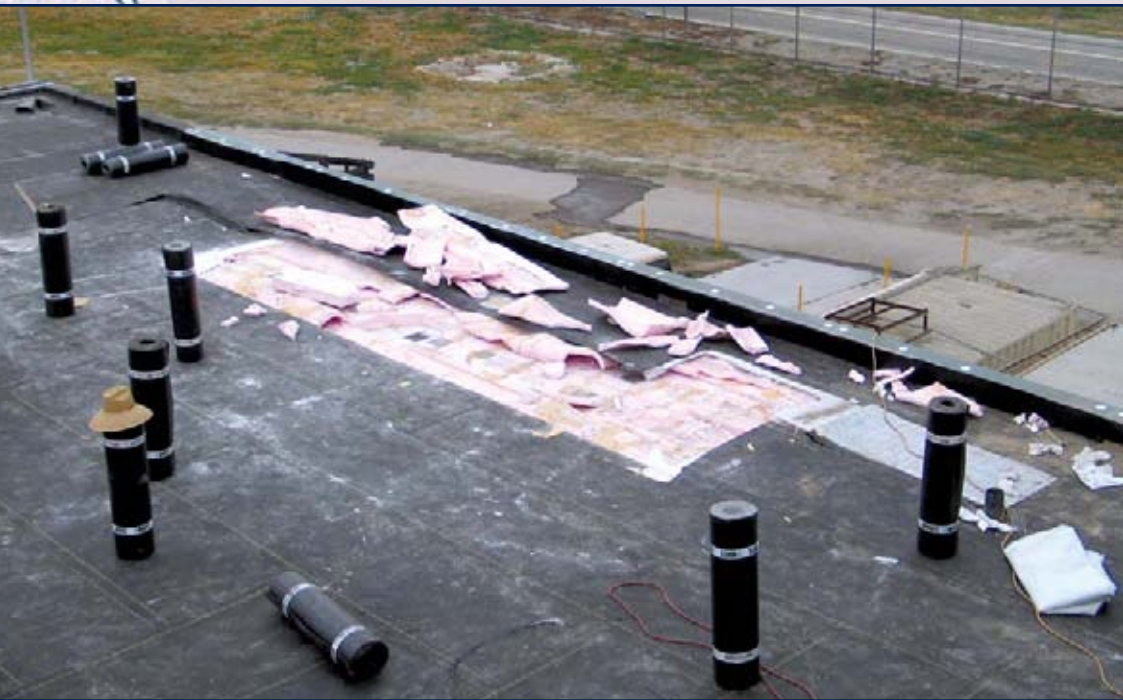
Left: An overview of an area where the reaction to heat build-up occurred.

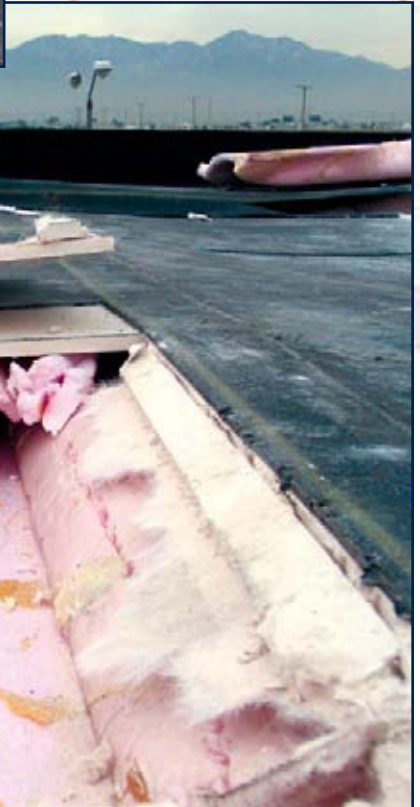
Below: The curling was so pronounced that it dislodged the 1/2-inch, glass-faced gypsum coverboard that had been adhered with urethane adhesive to the top layer of the EXPS.

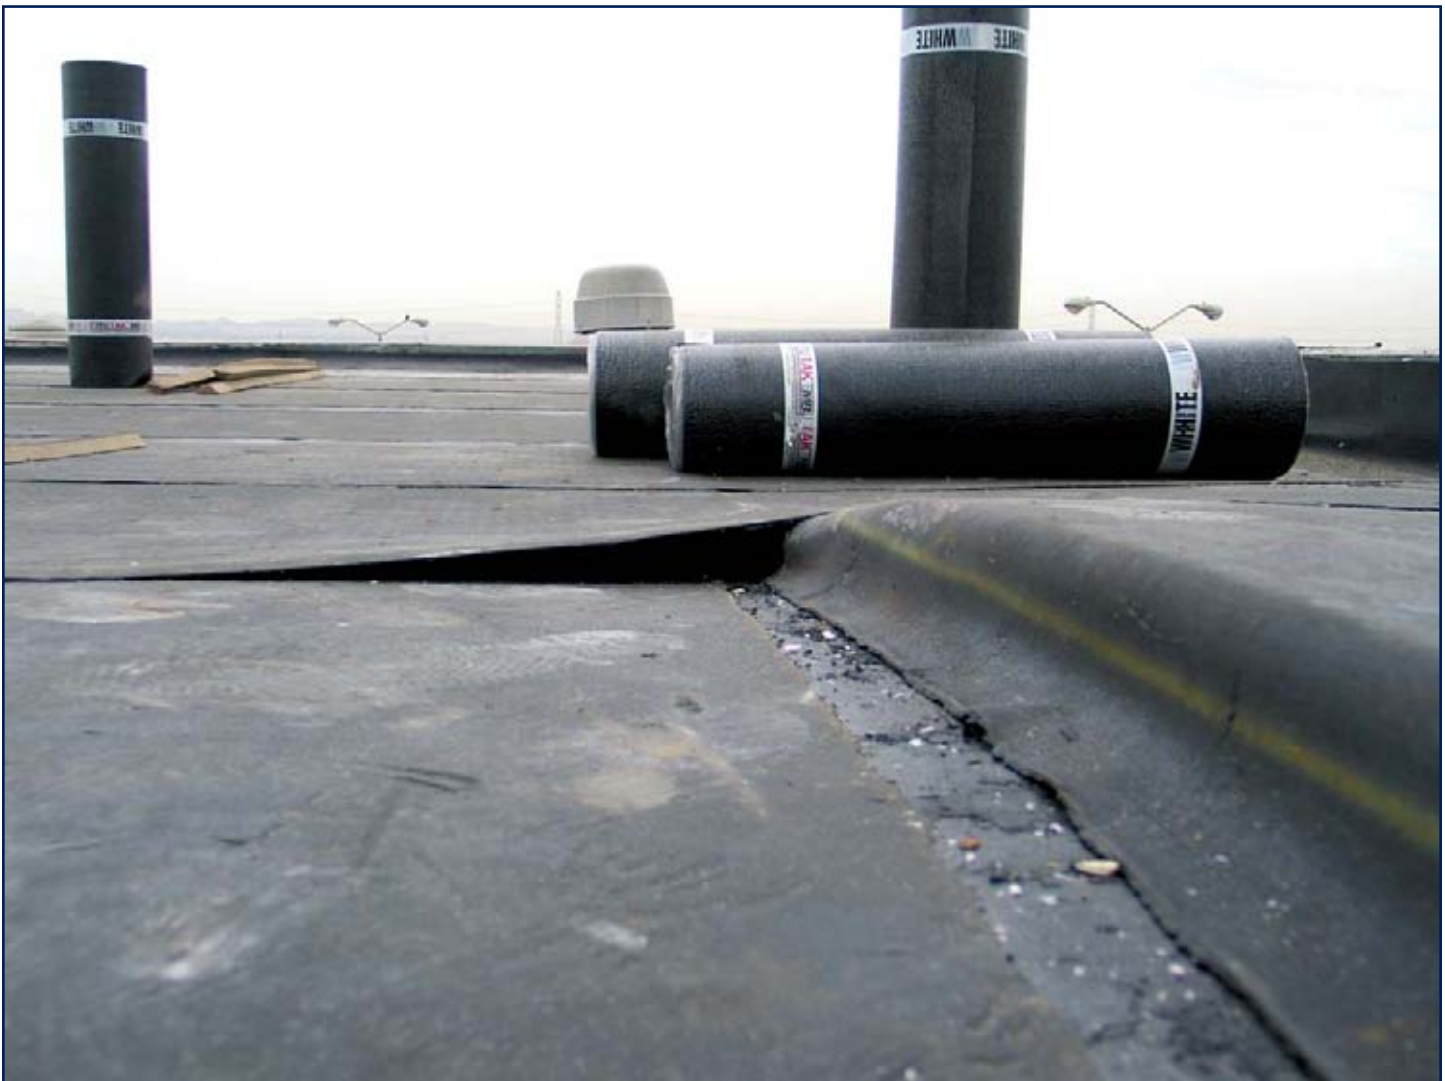
A side view showing the profile of a lifted area prior to roof cuts for visual observation.
