UNUSUAL SUSPECTS

By E. Frank Kelm, RRC

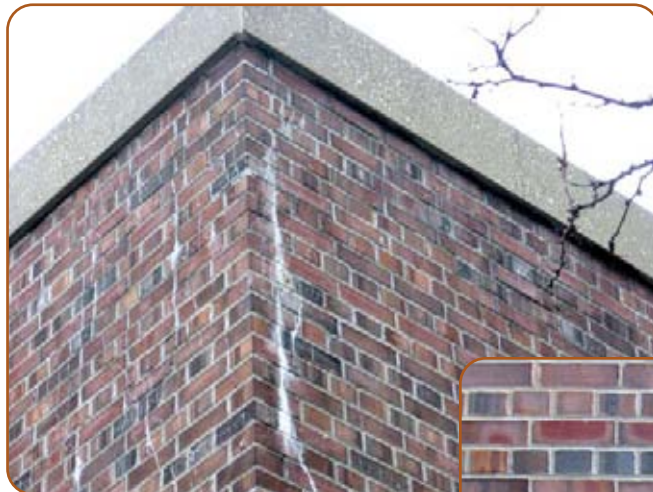
Upon arrival, it could clearly be seen that the existing control joint had separated. A large amount of staining, or what appeared to be efflorescence, occurred on the brick veneer of the addition.

Stained, cracked masonry units.

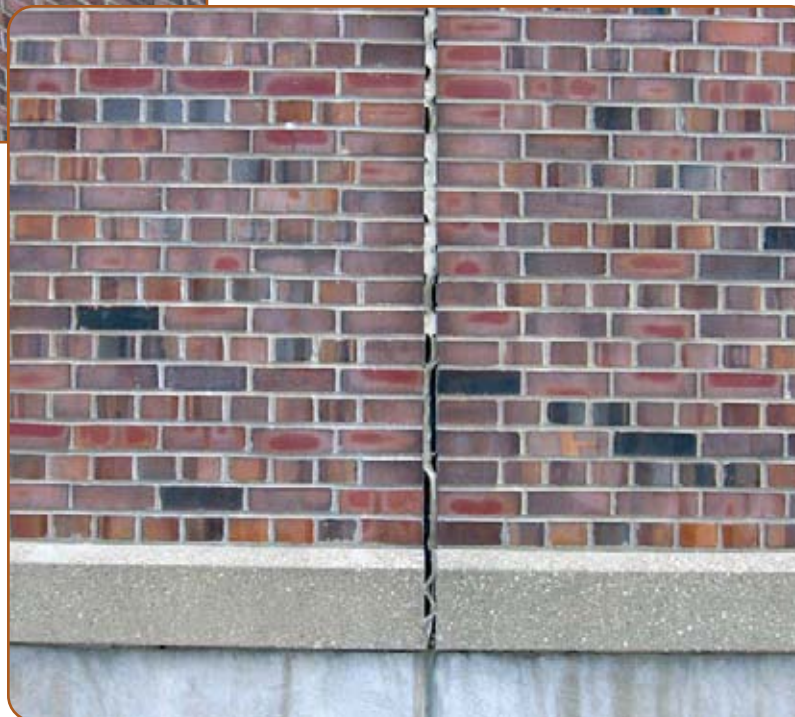
Separated expansion joint.

The engineer was fairly certain that the cracking was due to settlement caused by poor compaction and/or poor soils condition. A geotechnical investigation and soil report would be required to establish the structural repairs. Structural repairs were estimated at a construction cost of approximately \$30,000.

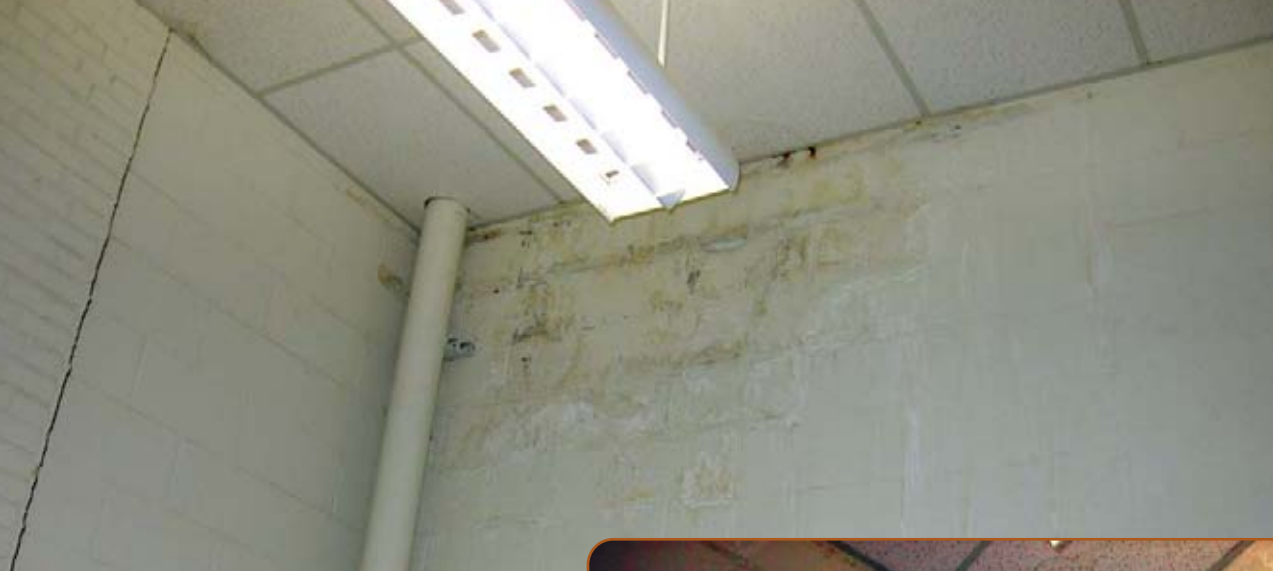
While the client described to the engineer the control joint and how it was getting wider, the author took stock of the general condition of the room. Several ceiling tiles were stained and portions of the interior wall were water damaged. The client said they “couldn’t keep the ceiling tiles replaced.” Had they considered the possibility of a roof leak? the owner was asked.

Left: Interior wall and ceiling damage.

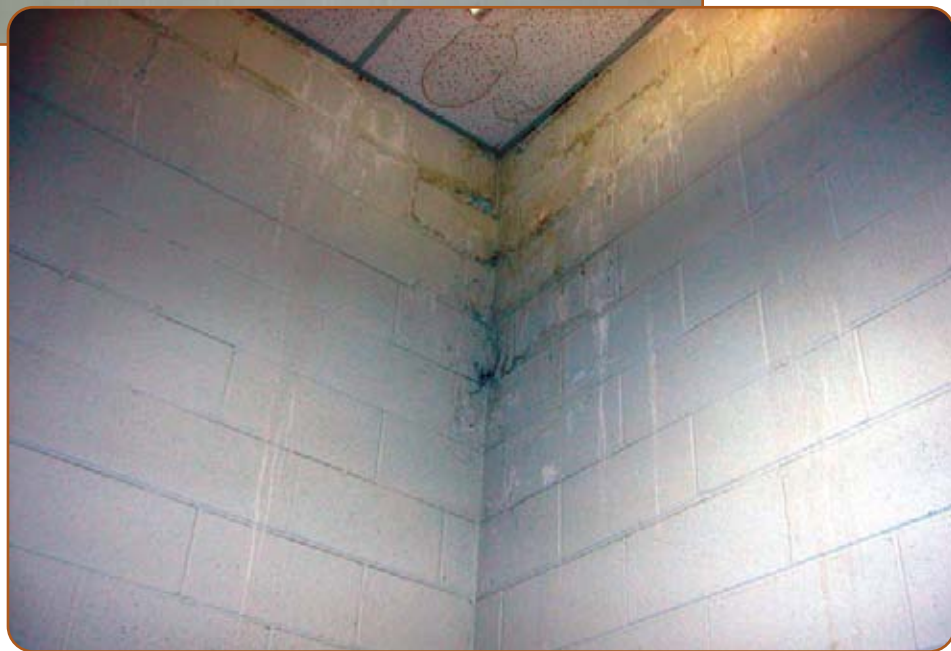
Below: Interior damage.

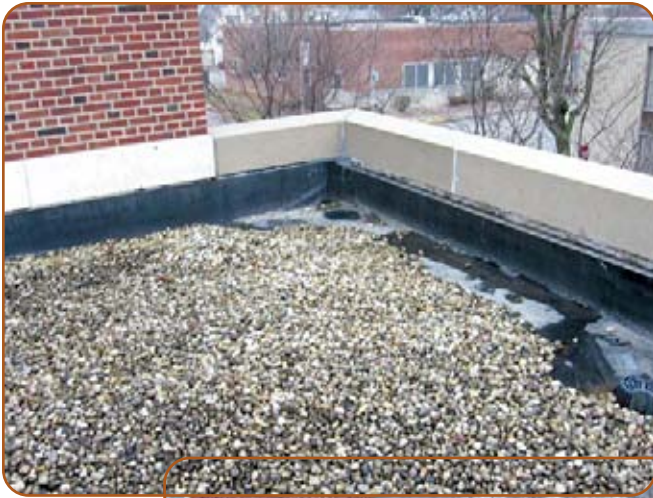
The author noticed, however, a recently applied bead of caulking along the bed joint of the stone coping. When a section of caulking was peeled away, it was obvious that it had covered a small crack between the coping and the parapet wall. Looking along the interior and exterior bed joints of the coping stone, there was no evidence of a through-wall flashing or weeps.

Above: Roof perimeter showing coping stone.

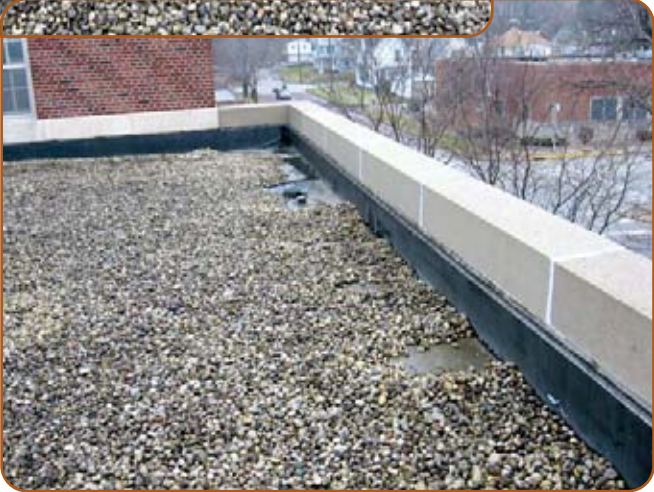
Right: Overview of roof edge.

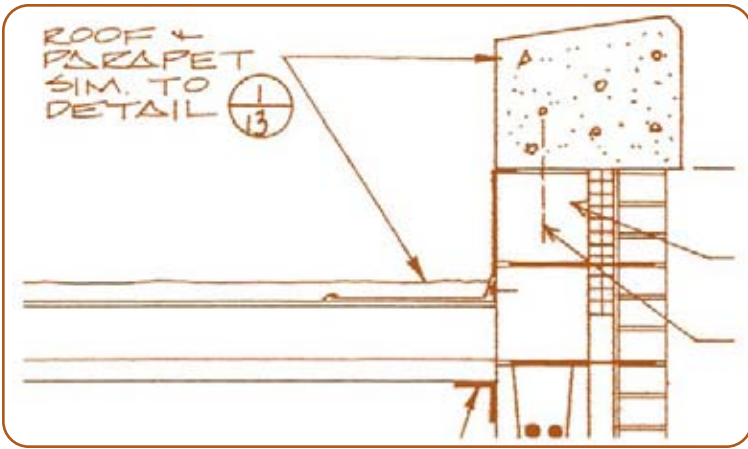
- The coping stone had been set directly on top of the masonry without a through-wall flashing.
- The wall cavity is 2-3/8-inches wide with two inches of rigid insulation, leaving only a 3/8-inch clear space for drainage.
- The coping stone lacks a defined drip edge.

The addition struck out on all three requirements. A through-wall flashing placed under the coping would have diverted water penetrating the coping and its joints to the exterior, preventing it from entering the wall cavity. A well-defined drip edge would have stopped most water drips from reaching the bed joint of the coping (and entering the wall through capillary action). Finally, a 1-inch cavity is deemed as the minimum clearance required for both proper construction and to allow the wall to drain.

Exterior wall coping detail.

The masonry repairs will prove to be more extensive and costly. The existing coping stone could be removed and salvaged for re-use, with new through-wall flashings installed, deteriorated portions of the brick veneer demolished and replaced (approximately one-third of the wall), damaged and wet cavity insulation removed and replaced, and the remaining brick ties examined for corrosion and repaired as needed.

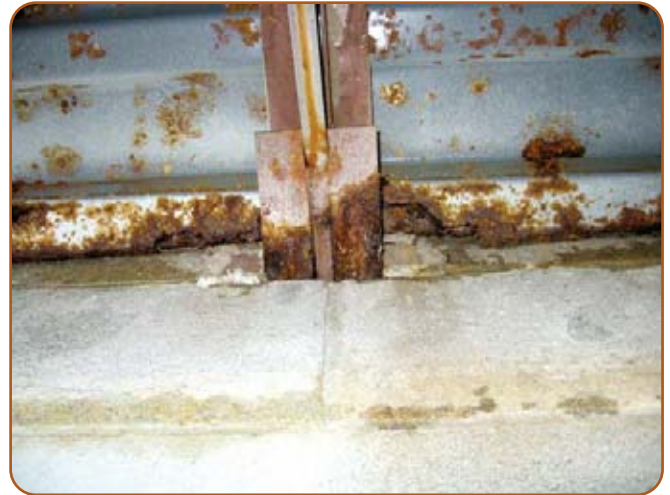
In addition, there was corrosion on the underside of the steel decking and bar joists. It was also apparent that the corrosion was more severe where these components contacted or penetrated the exterior wall. In fact, a portion of steel decking locat-

ed next to the wall was perforated by corrosion. The steel joists bear upon the inner CMU wall and the joist pockets appeared to be reasonably sealed. Portions of the CMU wall showed evidence of efflorescence, staining, and dampness.

Deteriorated metal decking.

A brief recap of the roof consultant's findings of the roof and exterior walls of the addition showed that at a minimum, the wet roof insulation and deteriorated metal decking should be removed and replaced for an estimated cost of approximately \$5,000. This left the client with a 15-year-old ballasted roof, which might not be the best investment of \$5,000. An estimated cost of \$16,500 was given to replace the ballasted roof with a fully adhered one, and included the cost to replace deteriorated metal decking.
