THE ART OF REPLICATING AND SOURCING LEAKS TO THE INTERIOR OF BUILDINGS;

ENGINEERED DOCTRINE OR APPLIED FUNDAMENTALS?

BY DON KILPATRICK

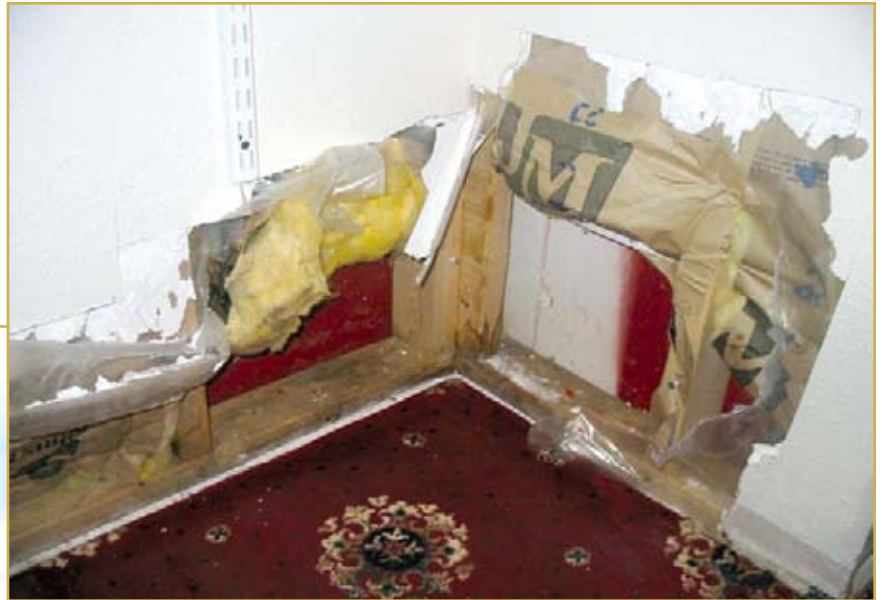
Right: Photo 1 – Damage to interior finishes at basement floor line.

A townhouse complex in the upper Midwest reported persistent leakage into the basement of several units (*Photo 1*). The water first showed up at the juncture of the rim joist and sub-floor, slowly migrating down the foundation wall as evidenced in one of the units with an unfinished basement. Other owners had installed clever interior drain tiles to channel water harmlessly into a pail set on the floor. A stone veneer was present over the wood-framed chimney enclosure that was, for all practical purposes, centered over the leak location (*Photo 2*). The townhouse association

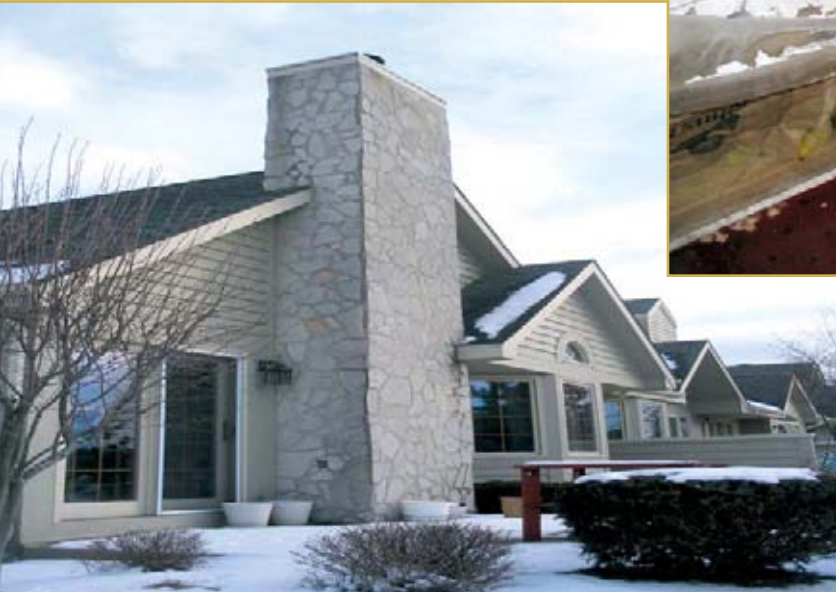
Below: Photo 2 – Typical wood-framed, stone-clad chimney enclosure.

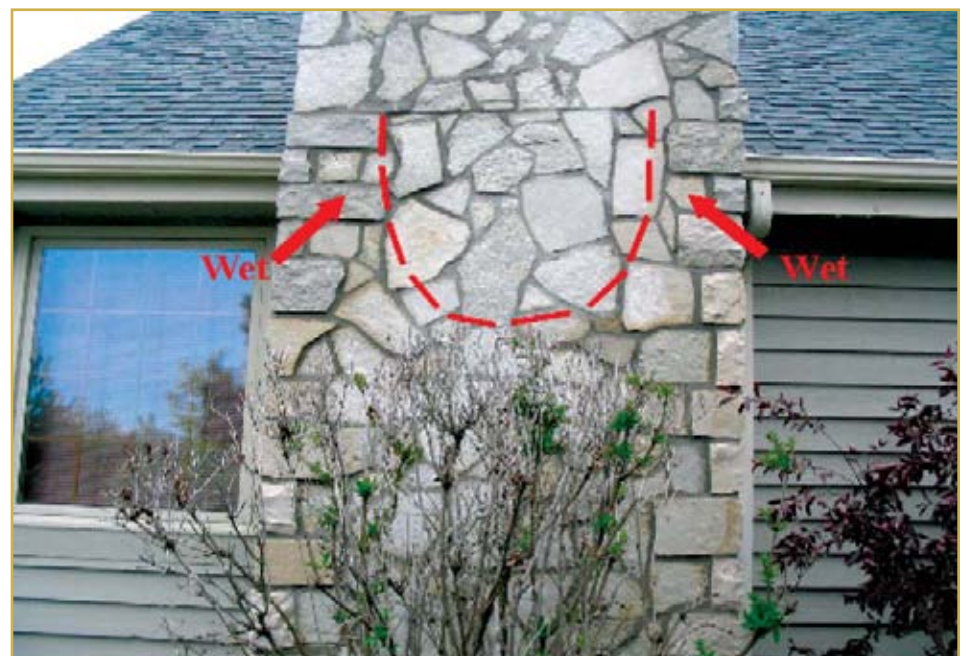
Photo 3 – The "U"-shaped pattern established as the wet stone cladding began to dry.

The sun broke through the thinning clouds, and the cladding features began to dry. Interestingly, the drying of the stone cladding on the chimney soon developed a pattern consistent with a horseshoe. The center of the “U”-shaped pattern was notably drier than the outside corners. The drying pattern suggested that the largest volume of water had entered the stone-clad chimney somewhere at or above the roof line (Photo 3). The above-described conditions prompted a visual examination of the roof and interfaced flashings of the stone-clad chimney.

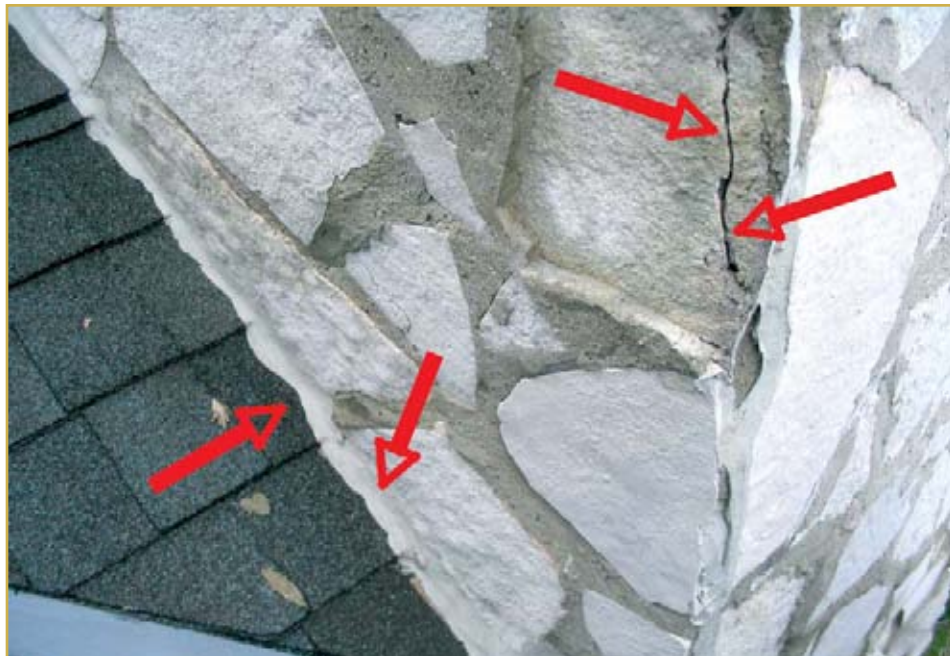
Photo 4 – Removal of loose stone cladding revealed openings in mortar bed. The shingle covering the interface with the stone cladding is sealed with caulking, restricting the harmless discharge of water from the above-roofline features.

At this location (much as described by the long-term resident handyman), it was noted that the shingle roof covering had been sealed with a liberal application of caulking directly to the stone cladding (Photo 4). As the open stone-to-stone joinery above the roof line was accepting water, the handyman’s efforts with the strategically placed sealant bead had effectively closed the only opportunity for the moisture to harmlessly exit the wall section. In summary, on this day, our hoses never saw the bib. The water test (more importantly, the dry-

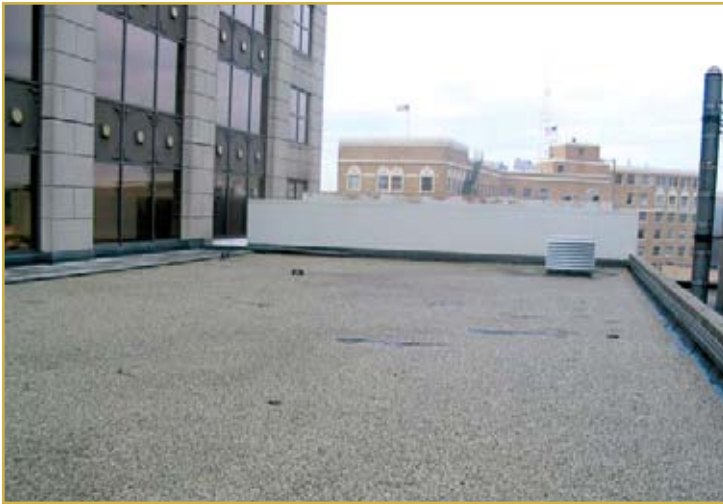
Left: Photo 5 – Overall of involved roof area.

Metal cladding was present, with concealed fasteners to hat channels at two of the three perimeter walls. The third wall was shorter, with a surface-mounted, sheet-metal counterflashing extending over the membrane base flashing (*Photo 5*). The investigation began with a “head of water” test on the roof membrane, followed by a four-hour water test at the base of the curtain wall (*Photo 6*). At no time during the test did the rate of discharge increase from the supplemental drains or deck opening at the primary drains.

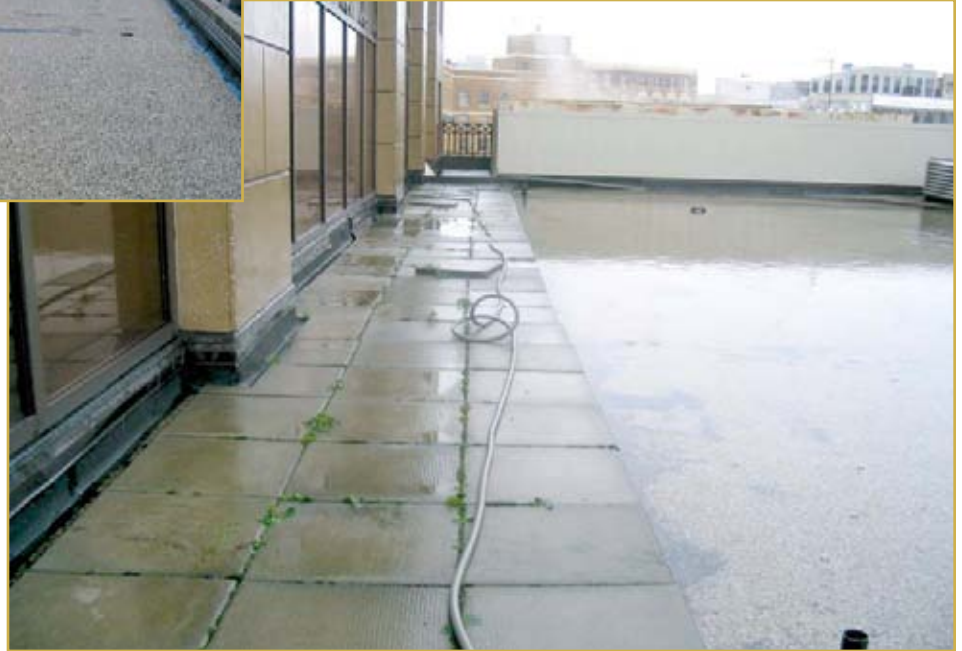
Below: Photo 6 – “Head of water” test on involved roof area.

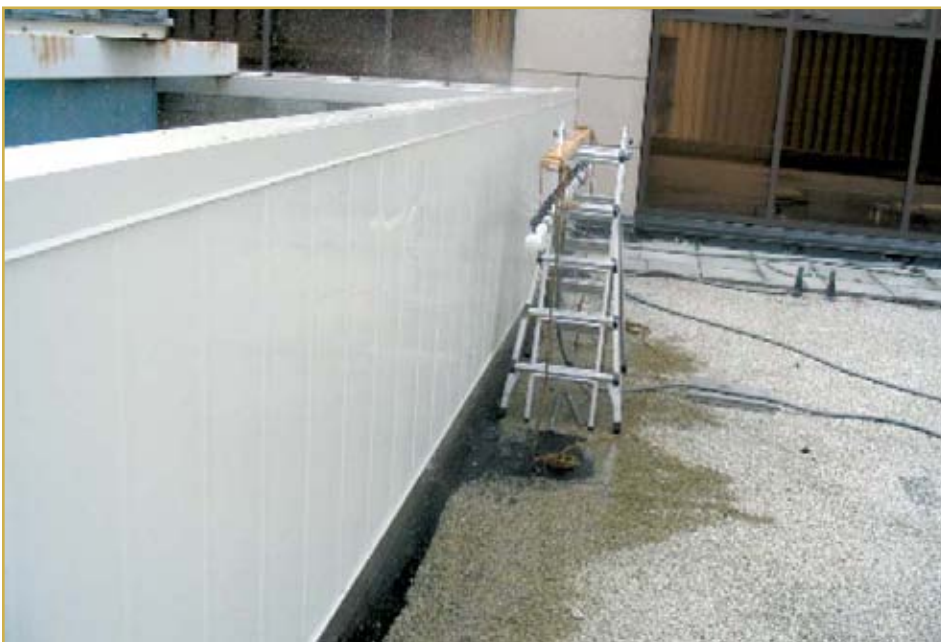
Photo 7 – Water test of the flat lock seam metal wall panel using a spray bar.

The spray bar (borrowed from ASTM standards, less the calibration) was then moved and directed at the flat-seam, metal wall panels for a duration of approximately two hours, or until there was a measurable increase in the rate of discharge – not from the supplemental drains, but the rough opening through the concrete roof deck for the drain bowl (*Photo 7*). Free moisture that made its way past the flat seam panels was

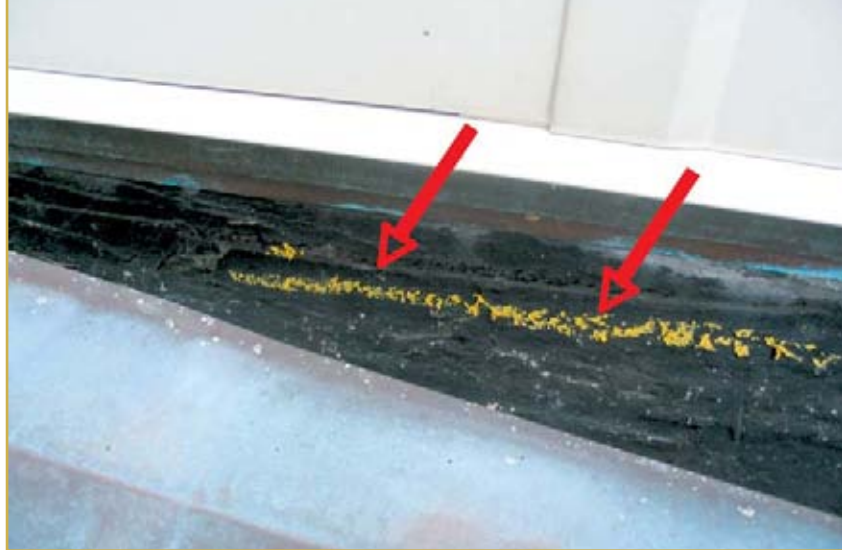
Photo 8 – Flashing termination accepting of water that moved throughout the joinery of the flat lock seam metal panel wall.

running down the concealed face of the CMU wall and entering the roof at the top of the base flashing. The top of these flashings was not secured to the block wall, due in part to the absence of a nailable substrate (*Photo 8*).

the water entry identified, the owner requested design services that included a drainage plane behind the reused, flat-seam, metal wall panels; a fully tapered and attached insulation system; and new modified roof, added slope, and improved drain-

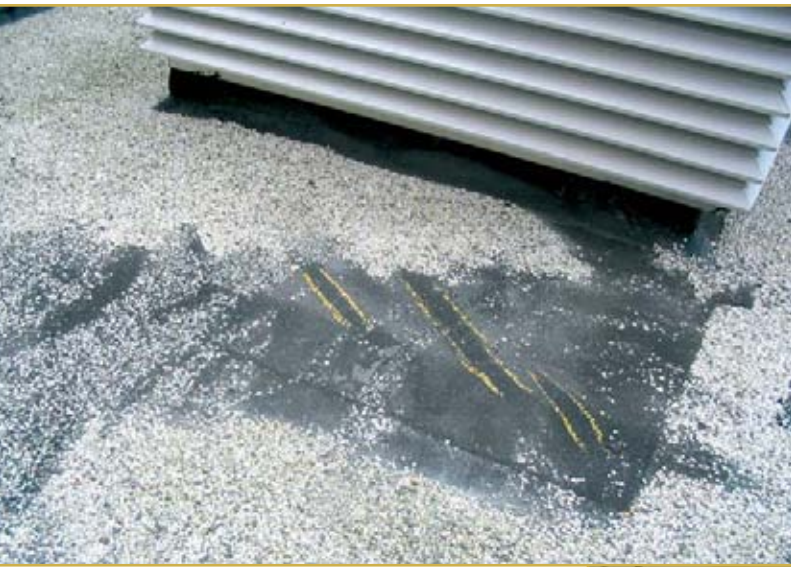
Photo 9 – Evidence of roof system movement in exposed membrane plies.

It was determined that the insulation section of the roof system was essentially loose-laid EPS over concrete, allowing system movement that manifested itself at the perimeter flashings in the form of a gap that would easily accept the moisture that moved past metal panels (*Photo 9*).

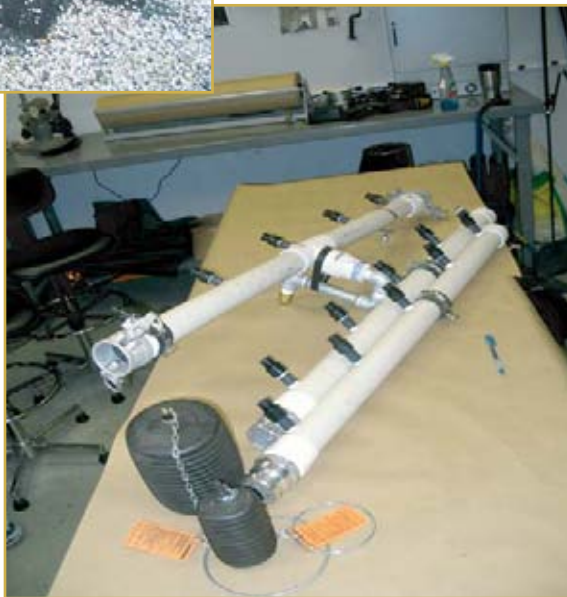
Photo 10 – Tools of the trade: shop-made spray bar and pneumatic drain plugs.
