# ENEMIES OF THE ROOF

BY JOHN W. WELLS, RRO

The case study presented here is based on a real-world investigation recently performed by Wells Klein Consulting Group (WKCG) on a building on the west coast of British Columbia. Brief portions of the report are excerpted and italicized herein.

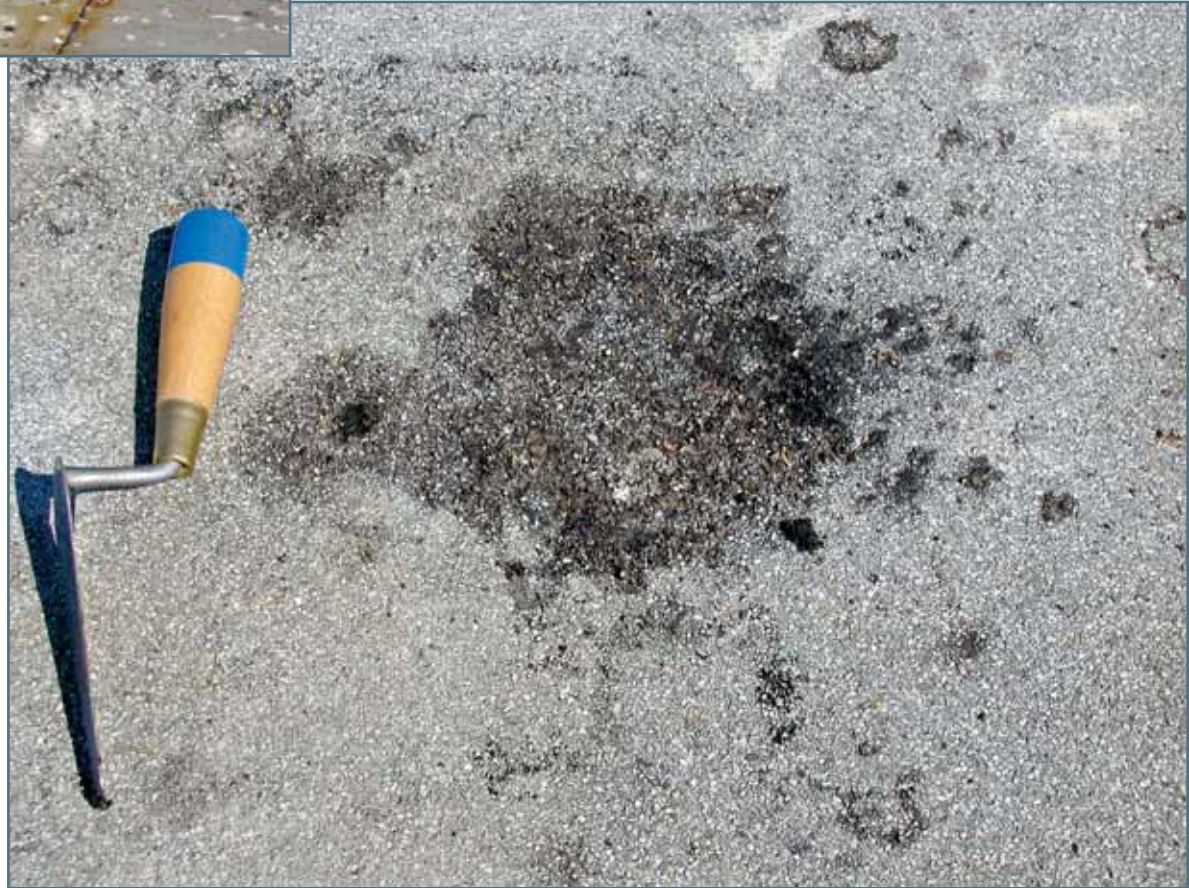
*Photo 3 – This picture demonstrates damage to the membrane that almost reaches the reinforcing mat. Granular degradation is devastating; the asphalt blend is softened and contaminated.*

In many spots, the effects of the droppings had actually not only removed granules, but softened or affected the top portion of the asphalt membrane proper, similar to hydrocarbon or oil contamination. In limited locations, membrane reinforcing had been exposed, indicating the erosion (removal) of granules and perhaps 1.5mm of asphalt sheet! (See Photo 3.)

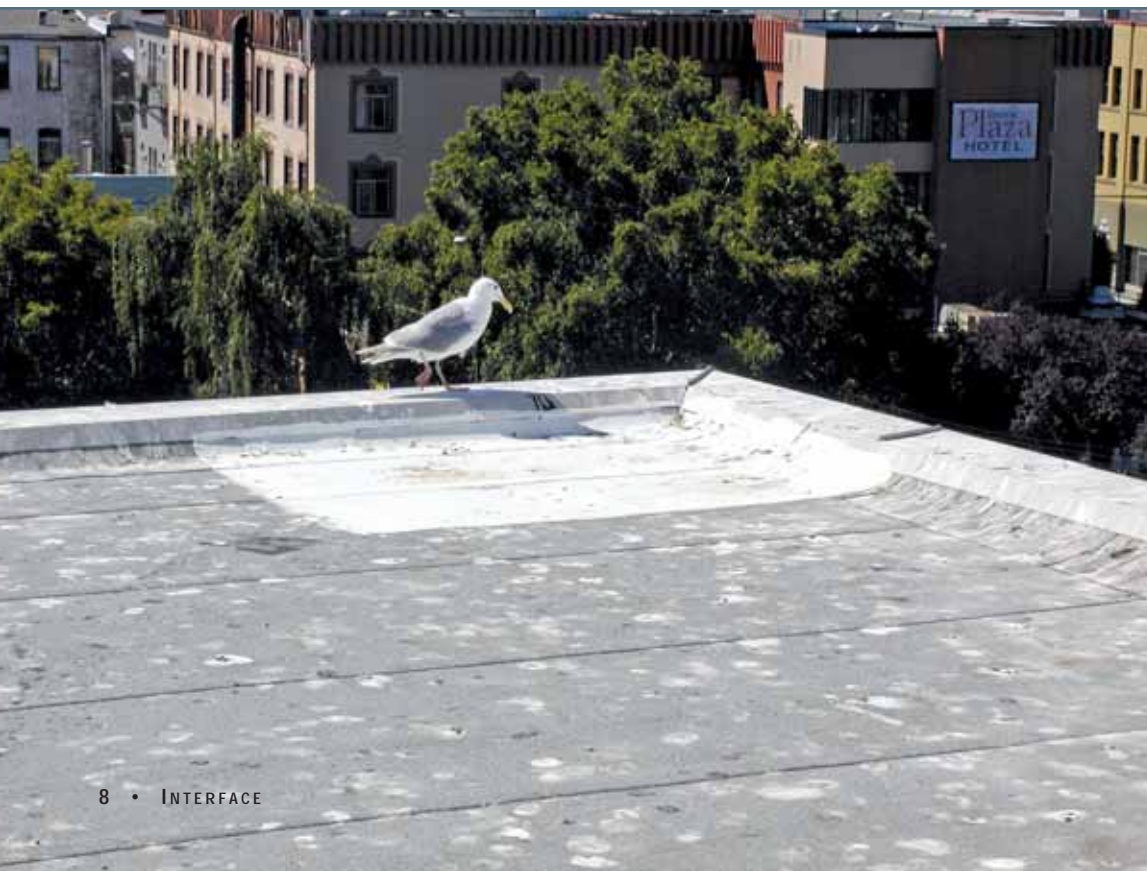
*Photo 5 – One of the attempts to “fix” the problem was an elastomeric coating. As demonstrated, the birds loved it. This particular coating proved ineffective.*

Membrane repairs on this building will be extensive and expensive in order to restore the roof to any semblance of its normal life expectancy. Specialized elastomeric coatings (see *Photo 5*), methacrylate coatings, an additional layer of cap sheet, or even the addition of a hot asphalt pour coat and gravel surfacing are plausible considerations.

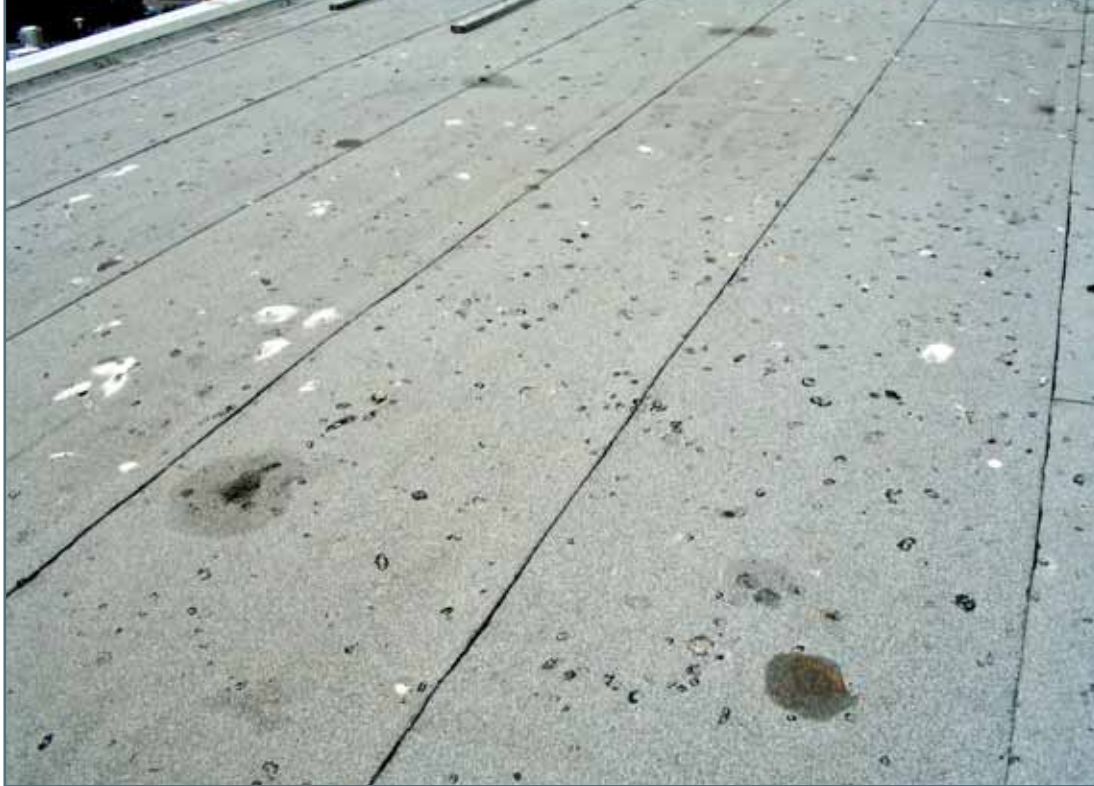
*Photo 6 – This photo was taken after the roof had been well washed by rain. The small, round marks are typical of granule loss damage to modified bitumen membrane caused by gull droppings. The larger, “splotchy” marks exhibit damage to the actual membrane, down to the reinforcing, in some locations. Some of what these birds eat and defecate dissolves or softens asphalt!*

order to keep the build-up of fecal matter to a minimum. Even if the coating protects the membrane as envisioned, the bird droppings will still have to be eliminated if further build-ups occur. Extreme care must be taken not to remove protective granules

unless another protective measure is identified (see *Photo 6*).
