Lessons Learned From Leakage Through a Subgrade Slab Geotextile/Bentonite/Geotextile Composite Waterproofing Membrane

By Dr. Ian D. Peggs

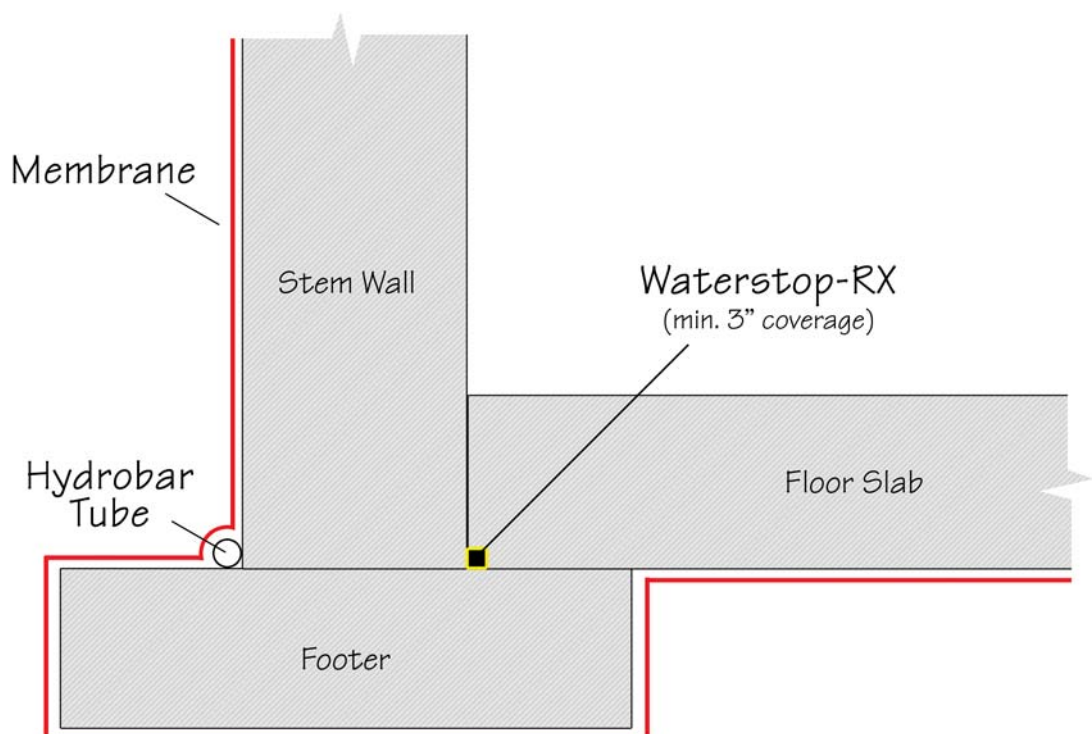
Figure 1 – Recommended cross section with hydrostatic head (CETCO).

In Figure 1, it should be noted that there is no expansion joint filler between the edge of the slab and the wall. More important, there is a waterstop at the triple point between slab, footing, and stem wall that prevents water from the outside and under the slab from rising between the stem wall and the edge of the floor slab. In the actual basement installation, the waterstop was

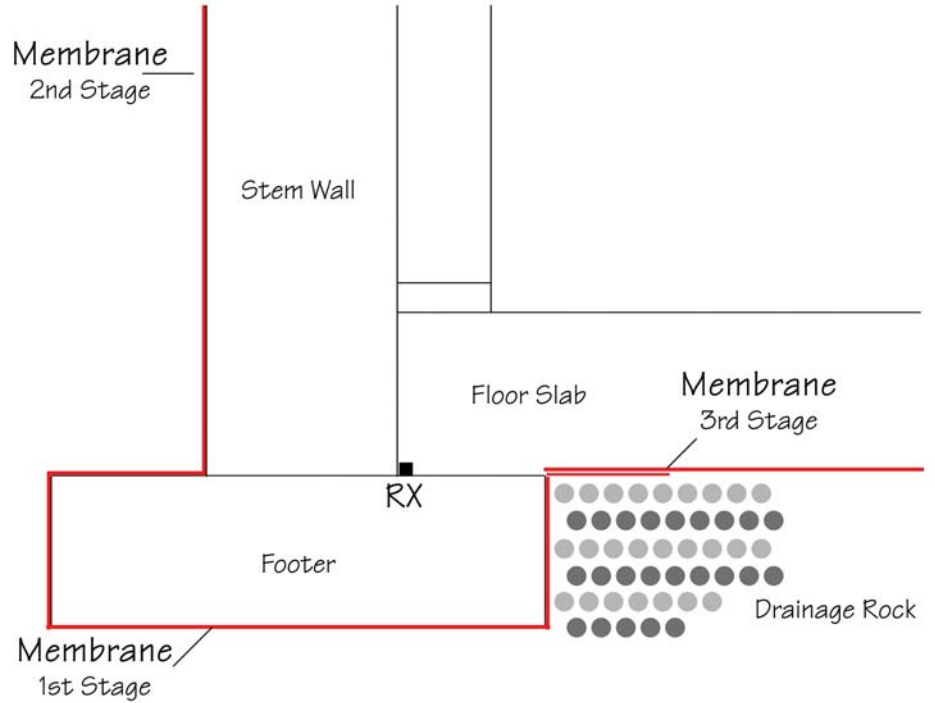
Figure 3 – Schematic of membrane location.

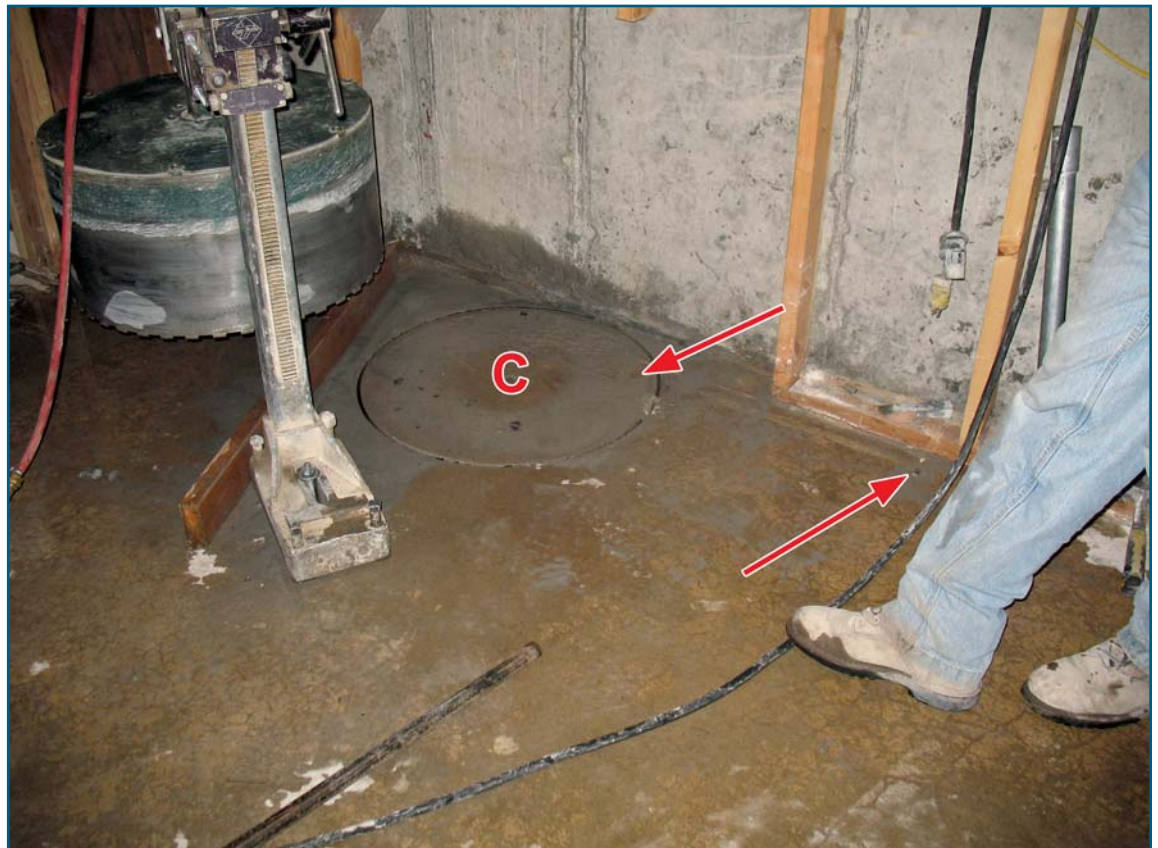
Figure 4 – Locations of core (C) and grout injection holes (at arrows).

A 24-in diameter core was removed from the floor slab as close to the stem wall as possible where studs had been removed (*Figure 4*) from the outside wall. The core included a hole drilled for grout injection during the second repair.

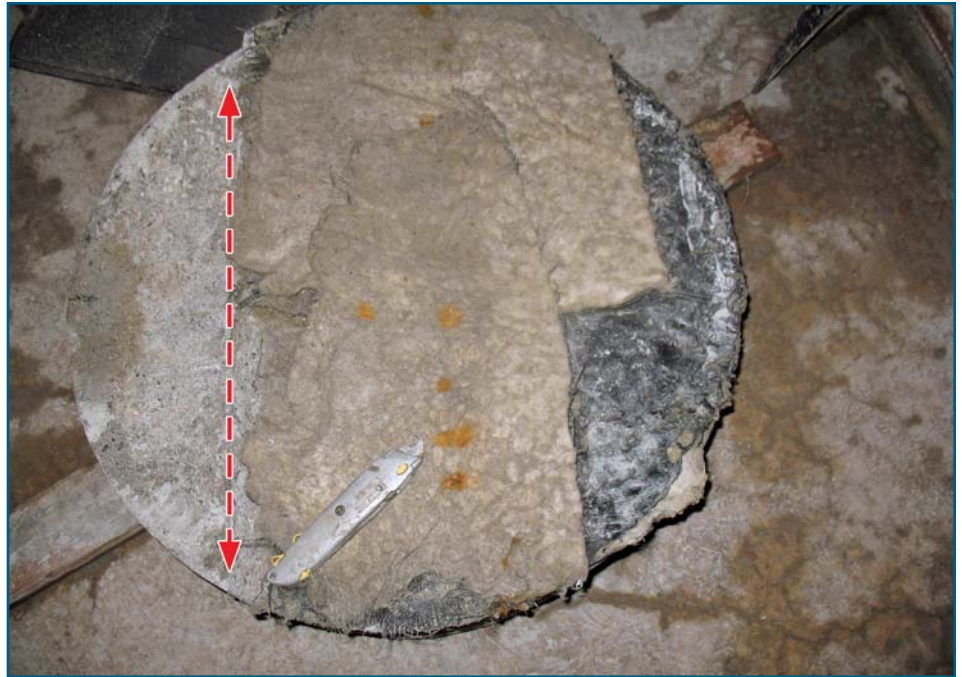
Figure 5 – Membrane layers on underside of core. Section on footing to left of dotted line.

When the core was removed, there were a few layers of membrane with various degrees of bonding attached to them (*Figure 5*). In the hole, the “smooth” top surface of the footing was obvious, but there was no evidence of repair grout on the top of the footing nor on the underside of the core above the footing, despite the fact that the injector hole went beyond the interface and into the footing (*Figure 6*). This hole was not filled with grout as it would have been had injection been successful.

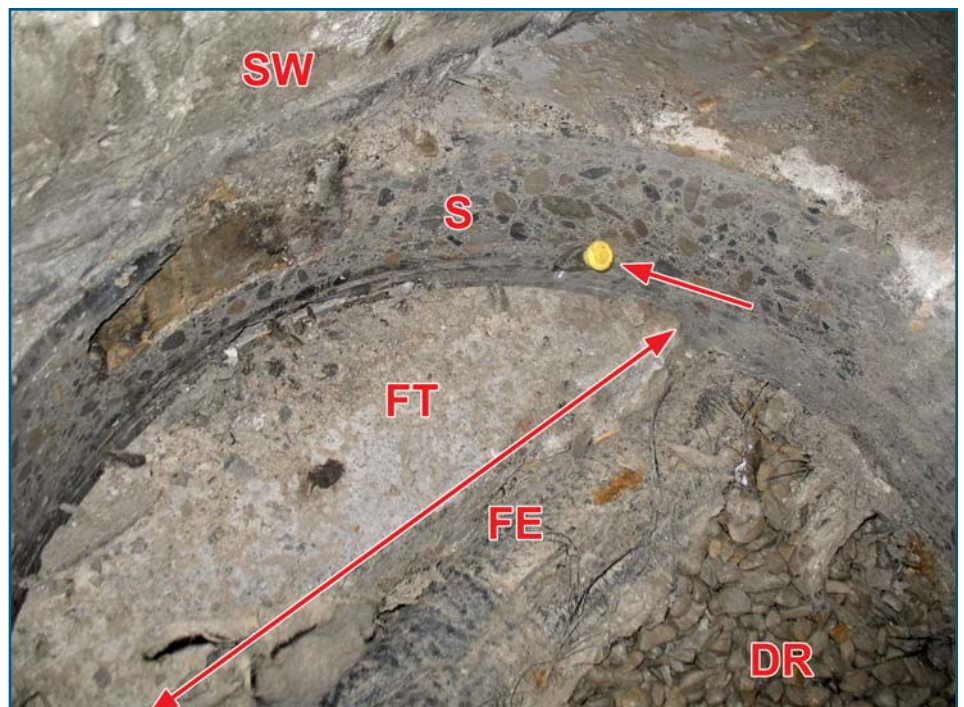
Figure 6 – Screwdriver (yellow top) in grout injection hole (arrowed). SW – stem wall; S – floor slab; FT – footing top; FE – footing edge; DR – drain rock.

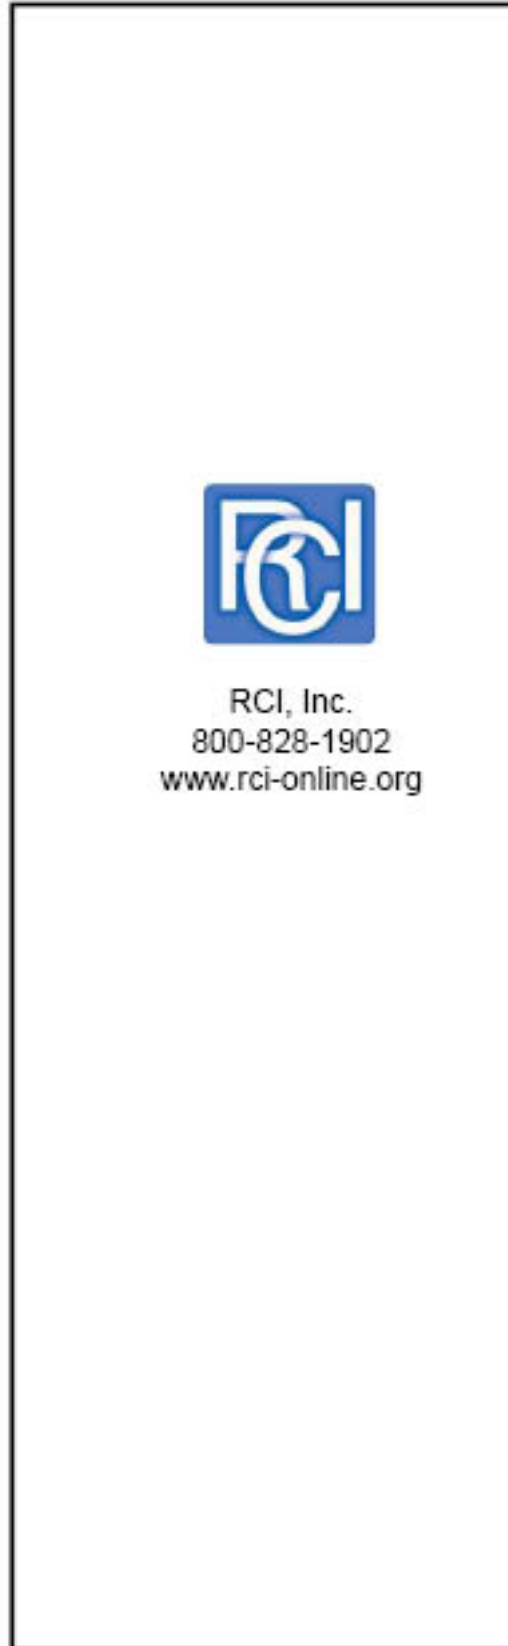
The gravel was removed, the membrane layers separated, and the side of the footing exposed. *Figure 8* shows the smooth side of the footing; but below it, there was a large, rough mass of concrete bulging out under the floor slab. There was no membrane bonded to the side of the footing nor to this rough, bulging mass. There was an overhang/channel (*Figure 9*) between the bottom of the smooth part of the footing and the bulging mass that would preclude the application of a uniform confining pressure on the membrane at that location. The channel would also allow passage and dispersal of leaked water behind the membrane.

Figure 8 – Smooth side of footing (FS) with bulging concrete (B) below. Footing top – (FT); Slab – (S).

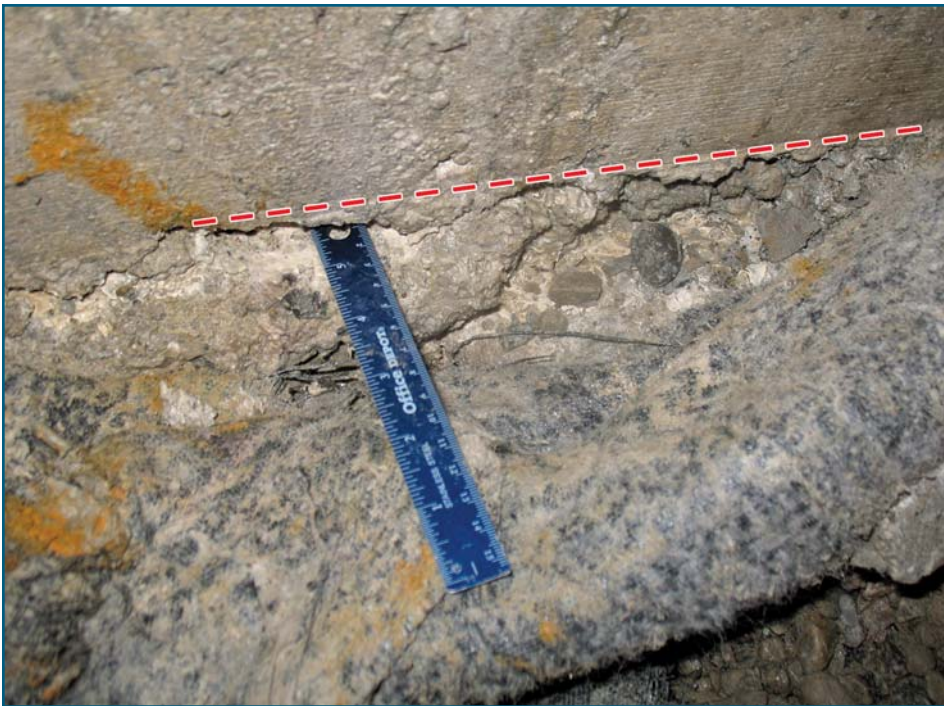
Figure 9 – Channel-like cavity in footing between smooth side (above dotted line) and bulge.

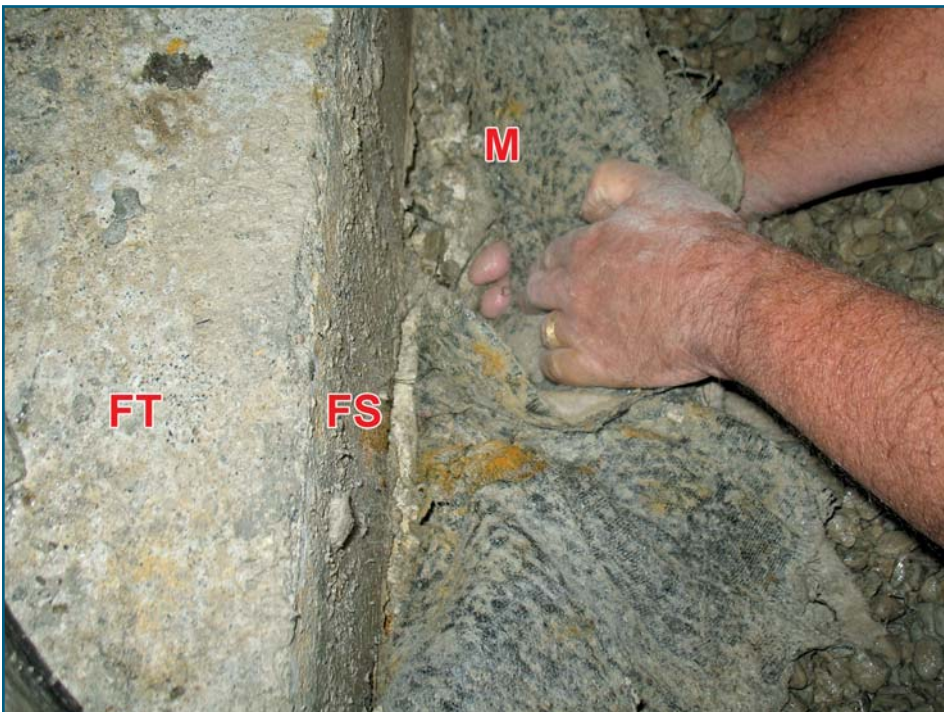
Attempts to sort out the layers of membrane revealed three or four layers. During separation of the membrane layers, there was one location where it was possible to put two fingers through a hole/gap from drain rock side to footing side (Figure 10). There had been a lump in the concrete bulge penetrating the liner at this location. This would have been a significant leak. It was also possible to reach well down the bulging concrete between concrete and membrane and to feel significant cavities in the concrete surface, even with the gravel in place. Thus, there had been inadequate and uneven confining pressure at these locations.

Figure 10 – Large hole through membrane layer (M). Footing side – (FS); Footing top – (FT).
