# SURVIVING NATURE'S FURY:

## PERFORMANCE OF ASPHALT SHINGLE ROOFS IN THE REAL WORLD

By Zhuzhao Liu, Hank Pogorzelski, Forrest Masters, Scott Tezak, and Timothy Reinhold

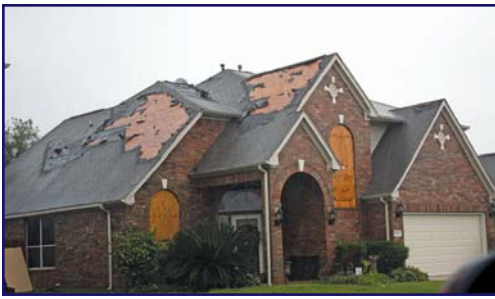
A. Widespread damage to roof shingles.

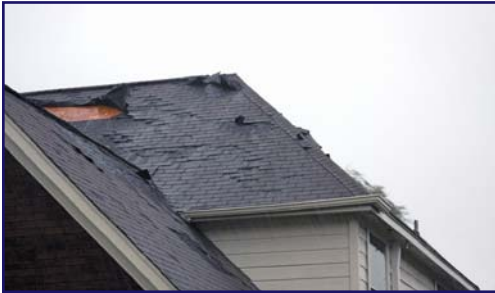
B. A large number of shingles blown off.

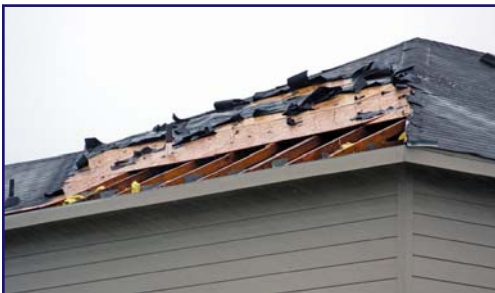
C. Heavy damage as a result of shingle and sheathing loss.

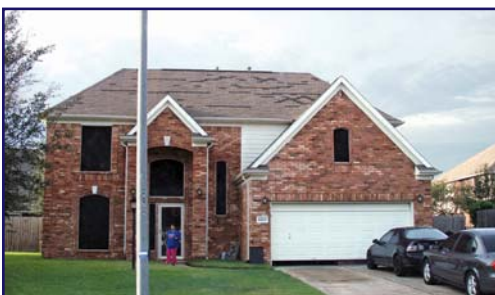
D. Wind uplift of individual tabs and shingles.

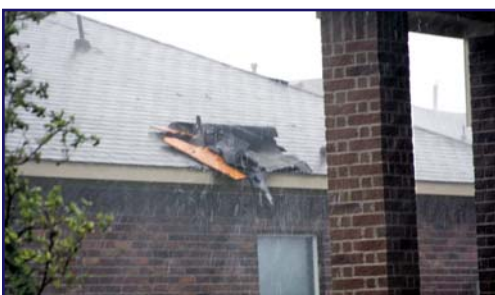
E. Sealant bonds.
