THE PECULIARITIES OF HISTORIC SLATE ROOFS WITH EXAMPLES OF WRONGFUL CONDEMNATIONS

BY JOSEPH JENKINS

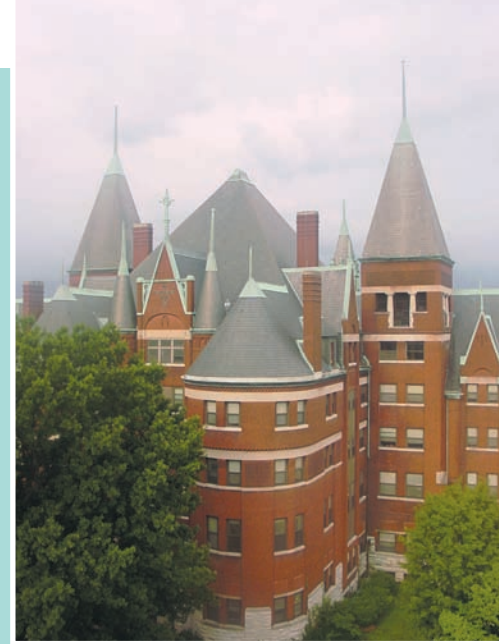
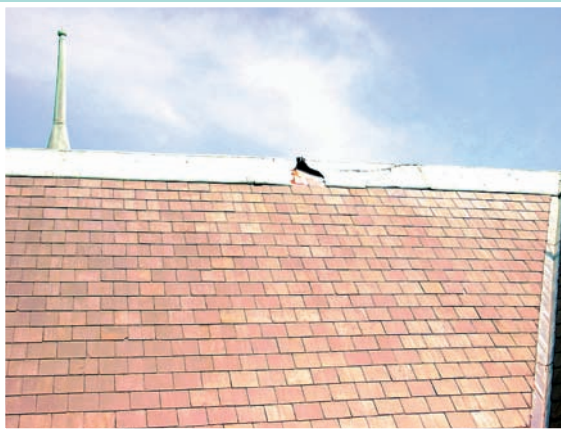
An inspection by the author revealed that the slates were a Buckingham or Peach

Bottom variety of exceptional quality. There was essentially no wear visible on the slates after 120 years. The very steep slopes and the semi-dry conditions of the area had helped preserve the copper, most of which was original. The wind and hail damage on the roof was quite limited and all of it was repairable for less than 3% of the replacement cost. The slates themselves could be expected to last another century, although the copper flashings would have to be replaced eventually. The main leak was in a copper valley and was unrelated to the storm damage. Although this beautiful slate could last at least another century, contractors were earnestly attempting to permanently destroy it.

The photo at right is only the entranceway to Castle Park, which has large wings emanating in three directions. The slate, at 120 years of age, is in excellent condition. Roofing contractors, however, would love to tear it off. Left: Minimal wind damage does not justify replacing the entire roof when the slate is still in good shape. (Photos by Joseph Jenkins.)

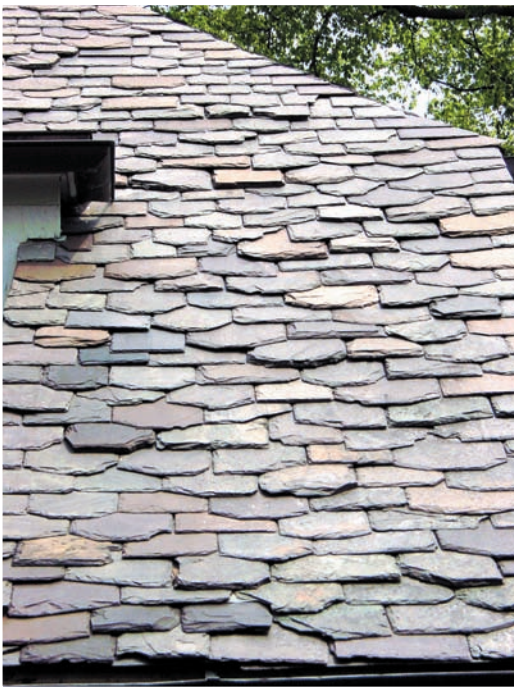
Chicago area home with beautiful 75-year-old “ragged butt” slate roof condemned by three roofing contractors. (Photo by Joseph Jenkins.)

A residence in an upscale Chicago neighborhood suffered hail damage to its unique “ragged butt” style 75-year-old slate roof. Three firms looked at the roof and all three condemned it before the owner contacted the author for an impartial inspection. Hail damage to the mixed Vermont and Buckingham slate was certainly evident, but it was limited and all readily repairable by any contractor with a minimum of slate roof restoration experience. The inspection revealed about 150 slates needing to be replaced – a couple days’ work for experienced professionals.

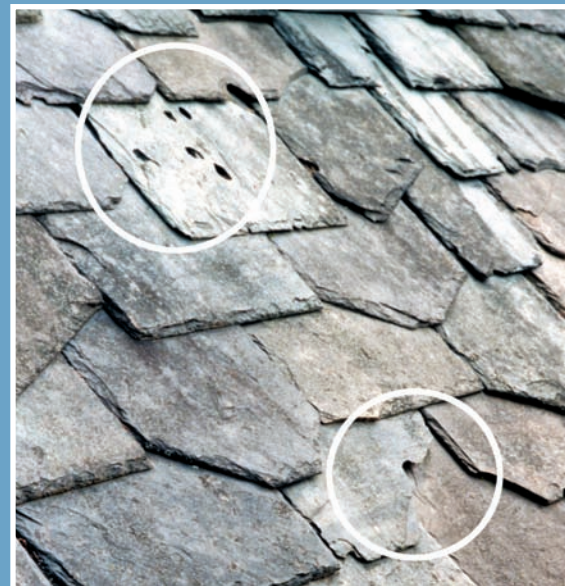
Hail damage of this nature, as seen on Chicago area “ragged butt” slate roof, is repairable by simply removing the damaged slates and replacing them. Most of the slates are undamaged. (Photo by Joseph Jenkins.)

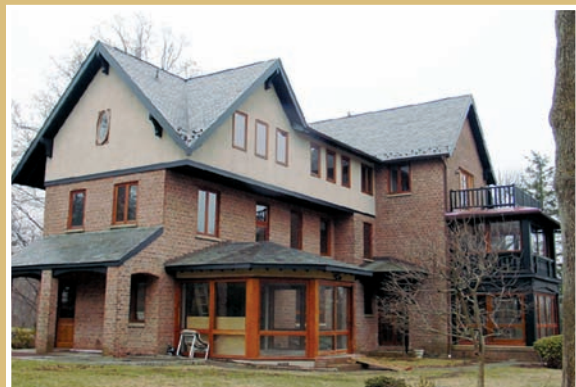
Ten-year-old slate roof on a private residence condemned by roofing contractors. The nominal snow guard damage, however, was covered by homeowner's insurance; the roof did not need to be replaced at all. (Photo by Joseph Jenkins.)

The author's inspection revealed that the snow guards had let loose due to severe weather that winter, combined with an inadequate number of snow guards for the size and slope of the roof. Each snow guard was hooked onto a slating nail, causing a slate to be pulled out with the snow guard. The damages amounted to a maximum of \$10,000 and all of it was covered by homeowner's insurance. Otherwise, the roof was fine. So much for "experts."

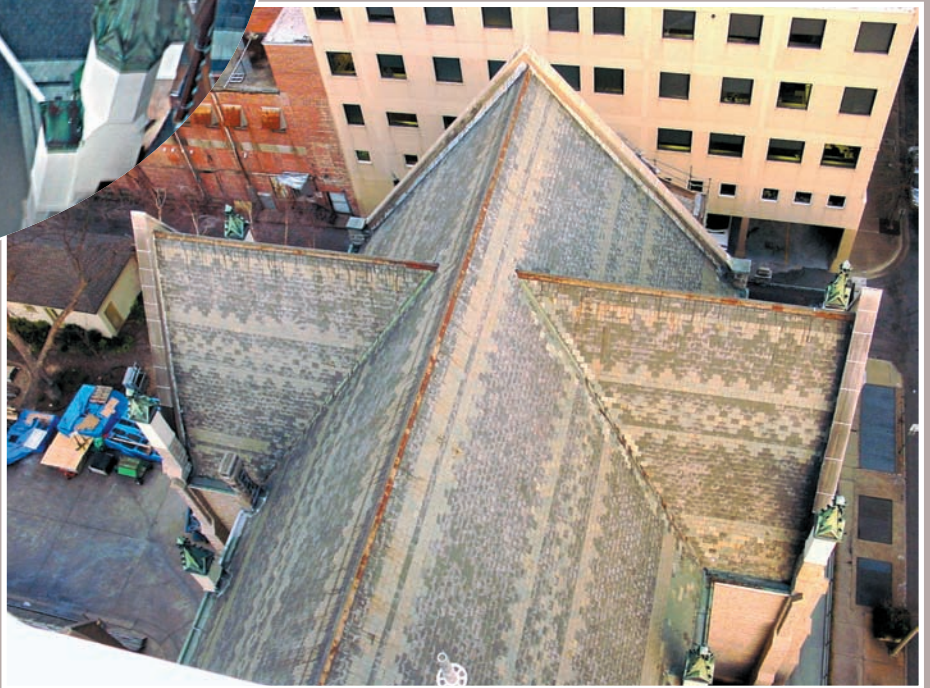
The Cathedral of St. Andrew in Little Rock, Arkansas, had worn out its black Pennsylvania slate after 120 years (below). The cathedral's new roof, left, installed by Midland Engineering in 2003, is likely to last 150 years. Vermont unfading green slate mixed with Welsh black slate and terne-coated stainless steel flashings should outperform the original roof. (Photo below by Joseph Jenkins; left photo by Lyle Bandurski.)

A slate roof will wear out, of course, and at the end of its life, nothing can save it. This was the case with the Cathedral of St. Andrew in Arkansas. The cathedral roof was made up of Pennsylvania black slates and Vermont unfading green slates mixed in an ornate pattern. At 120 years of age, the PA black slate had simply worn out – become soft, flaky, and falling apart – especially on the southern exposure and on the main body of the church. The Vermont unfading green slates showed almost no wear at all, despite their age of 120 years.

The original roof was inspected by the author to determine its condition and to draw up specifications for replacement. The new slate roof was subsequently installed by Midland Engineering of South Bend, Indiana, to match the original roof. This time, however, Vermont unfading green slates were mixed with Welsh black slates from Cwt-y-Bugail. All of the copper flashings were replaced with terne-coated stainless steel (some 4-lb. sheet lead was also used). The new slate roof is expected to last at least 150 years.
