Lessons Learned from 2004 Florida Hurricanes

from RICOWI (Roofing Industry Committee on Weather Issues) and SPRI (Single Ply Roofing Industry) are in the final phase of analyzing data collected in Florida just after the 2004 hurricanes.

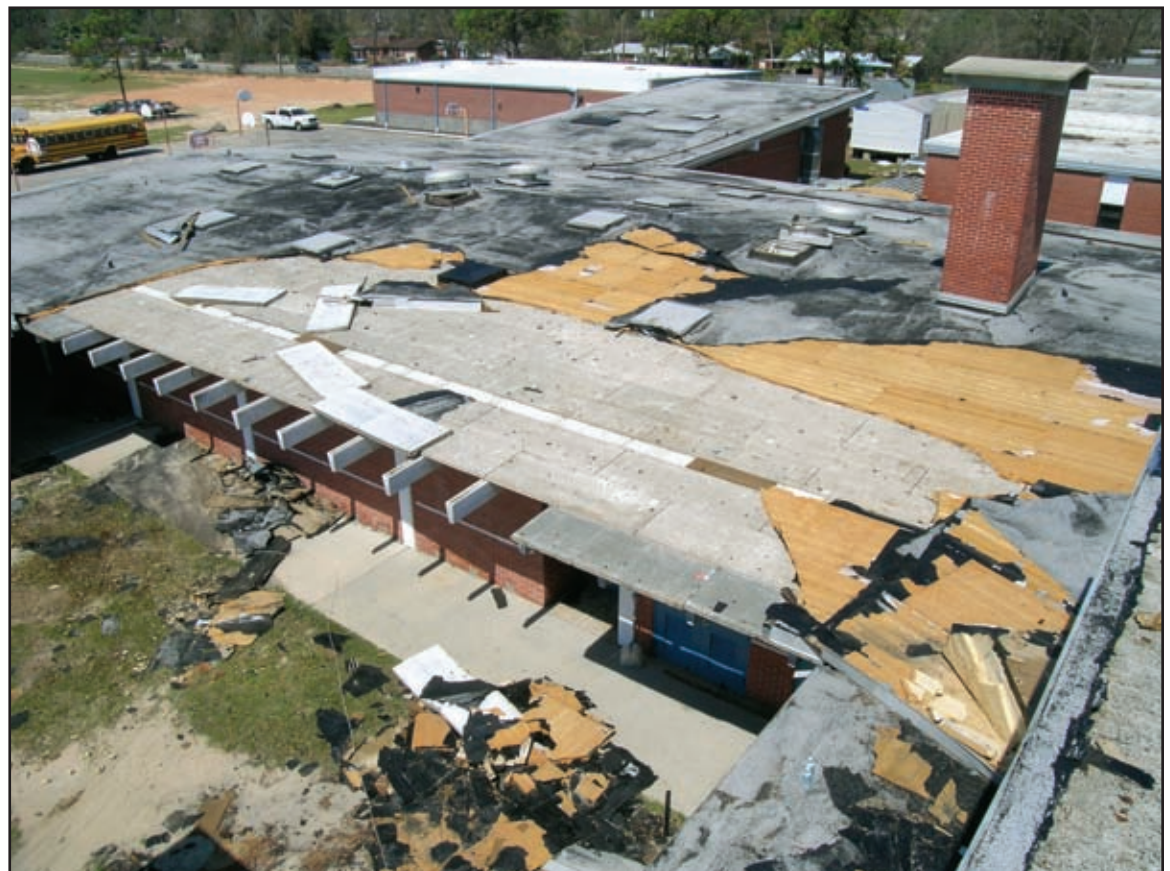
Pensacola School Building 1: RICOWI inspectors found pressurization and billowing at overhangs. There were cleat deformations and disengagement of edge metal. The cleat gauge was less than currently recommended by FM Global LPDS 1-49 and ANSI/SPRI ES-1. Corrosion reduced effective uplift resistance. Overhangs need to be designed and constructed to resist higher loads. (Source: André Desjarlais's Oak Ridge National Laboratory report, "RICOWI and its Investigations of Hurricanes Charley and Ivan")

Pensacola school building was damaged. The key points that surfaced from the investigation were that damage was initiated by pressurization and billowing at overhangs. This pressurization phenomenon caused cleats to yield, compromising the attachment of the edge metal. Progressive failure then rapidly followed.

Other findings were that the cleat gauge was less than currently recommended by FM Global LPDS 1-49 and ANSI/SPRI ES-1. In addition, corrosion of roof edge fasteners

contributed to expansion of edge damage into the field.

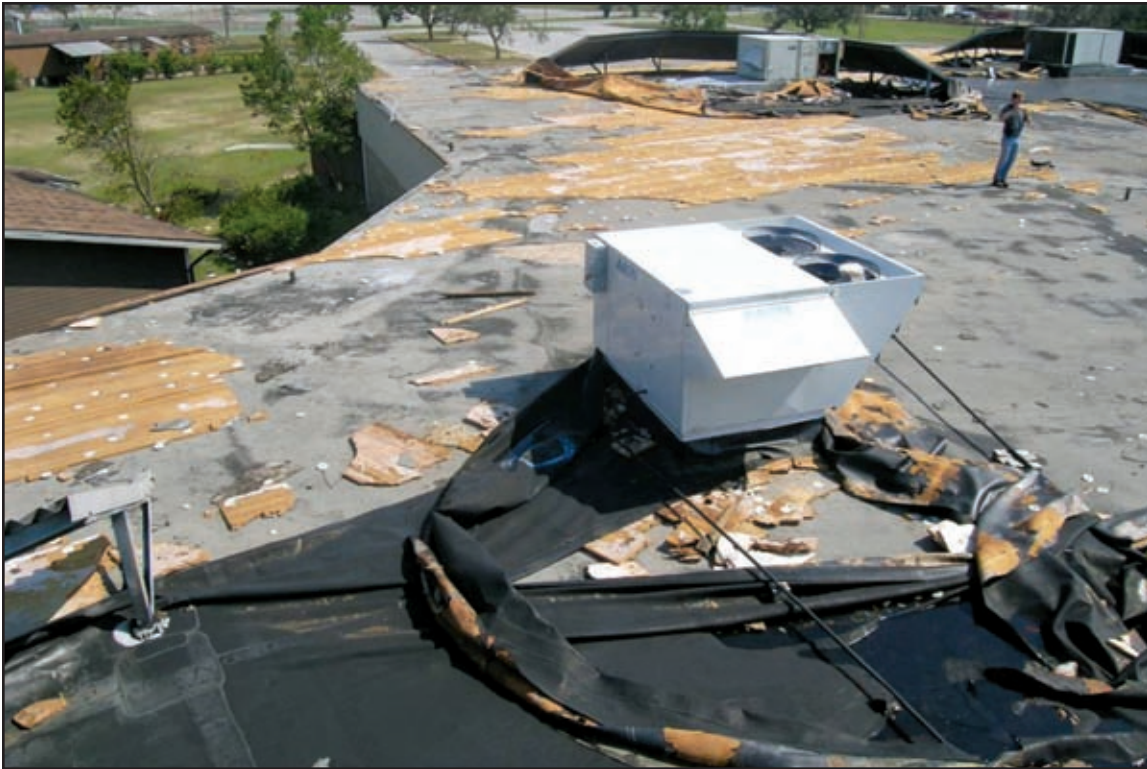
Pensacola School Building 2: Cleat deformed, edge metal lifted, membrane peeled. Cleat gauge less than currently recommended by FM Global LPDS 1-49 and ANSI/SPRI ES-1. Corrosion of roof edge fasteners contributed to expansion of edge damage into field. (Source: André Desjarlais's Oak Ridge National Laboratory report, "RICOWI and its Investigations of Hurricanes Charley and Ivan.")

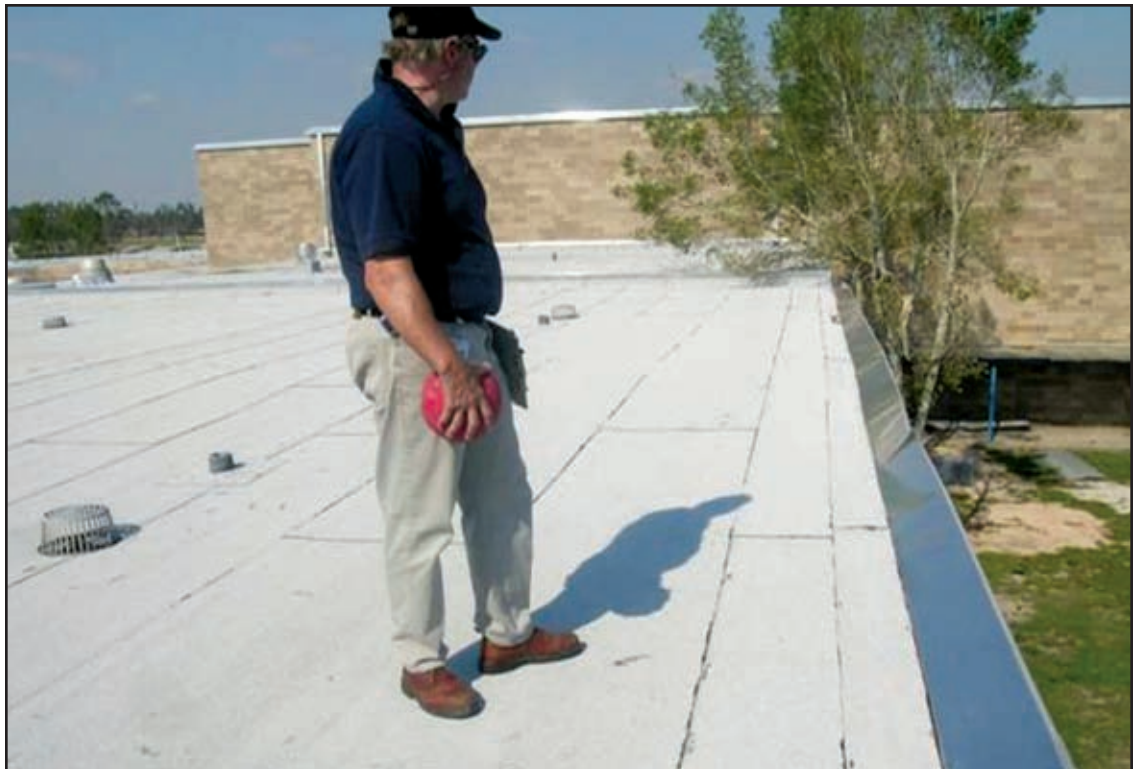
Pensacola School Building 3: Edge metal bent upward, nailers lifted, membrane base sheet torn around fasteners and peeled back. In this shot, the edge metal is bent upwards. The edge metal gauge and nailer securement are less than that currently recommended by FM Global LPDS 1-49 and ANSI/SPRU ES-1. Also, a lack of enhanced perimeter base sheet fastening contributed to propagation of edge damage into field area. (Source: André Desjarlais's Oak Ridge National Laboratory report, "RICOWI and its Investigations of Hurricanes Charley and Ivan.")

A second school building inspected in Pensacola had damage and propagation. The edge metal was bent upward, nailers lifted, and the membrane base sheet torn around fasteners and peeled back.

On closer inspection, the edge metal gauge and nailer securement were also less than currently recommended by FM Global LPDS 1-49 and ANSI/SPRU ES-1, and the lack of enhanced perimeter base sheet fastening contributed to propagation of edge damage into the field area.
