ANATOMY OF A LEAKAGE INVESTIGATION AT A CONCRETE FLOOR SLAB

BY LONNIE HAUGHTON

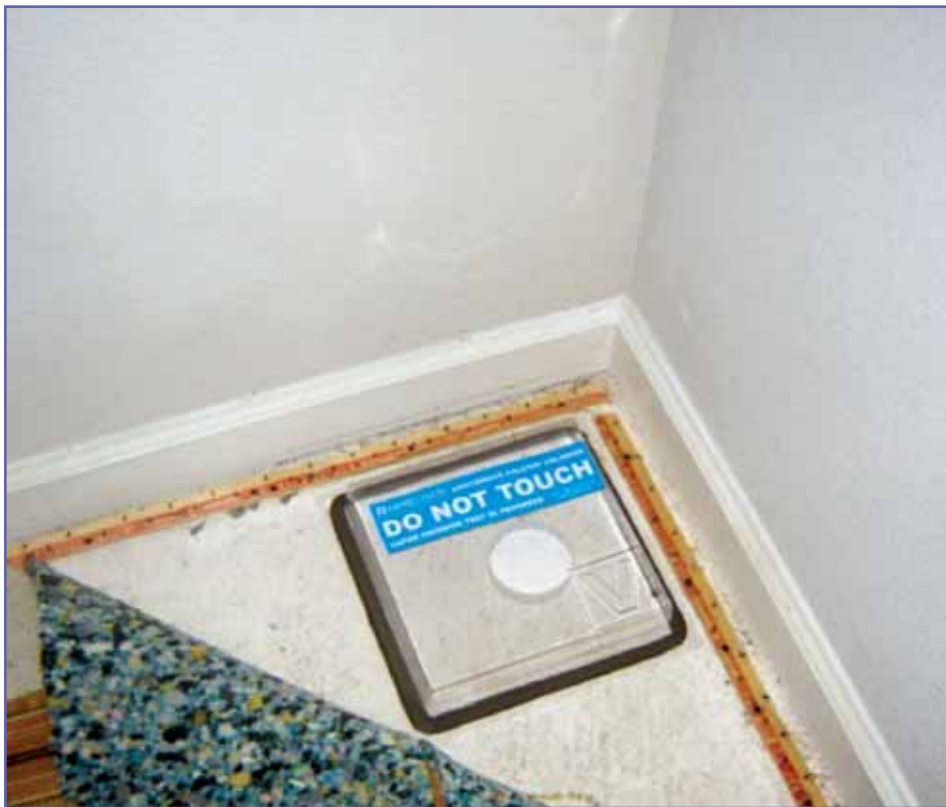
lematic vapor intrusion at a concrete floor slab. Basic tools for such concrete floor investigations include an electrical impedance moisture meter and a calcium chloride vapor emission testing kit⁴ (see *Photo 1*).

Photo 1 shows the placement of a vapor emission test dome adjacent to an apartment wall at which excessive vapor condensation was occurring at the interior side of a window positioned within the wall. A moisture meter confirmed that the surface moisture content of the concrete floor slab was unusually high. The subsequent calcium chloride test confirmed an unacceptable level of water vapor emissions into this bedroom. Based upon this information (and known conditions of failed waterproofing at other portions of the apartment complex),

Photo 1 – Calcium chloride vapor emission test dome installed at concrete floor slab

the inspectors made a preliminary hypothesis that the source of this problematic concentration of water was a waterproofing failure at the exterior courtyard opposite the walls seen in *Photo 1*.

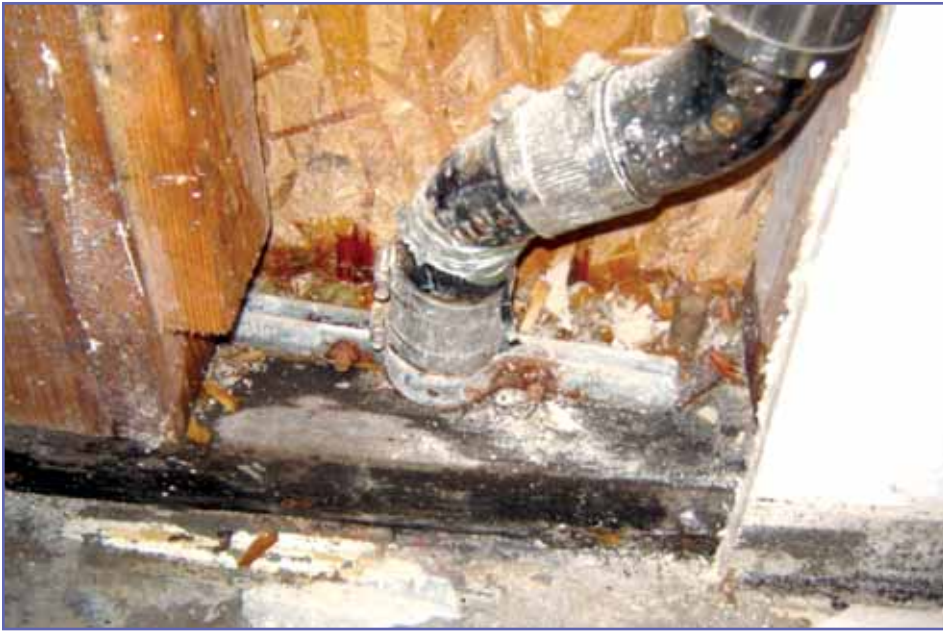
However, after an extended series of destructive investigations and testing, the investigative team discovered that the actual source of the water was a failed plumbing connection within an interior wall behind a clothes washer located in the opposite corner of the apartment (more than 25 feet from the affected bedroom window). Leakage from the drainage piping seen in *Photo 2* was being absorbed into the floor slab under the washing machine – eventually leading to semisaturation of the entire concrete slab and resulting in vapor condensation at the distant bedroom window.

Photo 2 – Hidden leakage at drain piping connection eventually resulted in vapor condensation at a bedroom window at the opposite end of the apartment.

In retrospect, at the commencement of the investigation described above, a small amount of nondestructive moisture/vapor testing at other floor slab locations might have quickly led the team toward the failed plumbing hidden behind the clothes washer. In addition to the moisture meters and vapor test domes commonly used to evaluate concrete floors, it even may have been prudent for the team to evaluate alternate areas of the floor slab with the relatively new “relative humidity probes” that entail drilling small holes into the concrete to measure the actual humidity level inside the concrete.⁵ Any such additional testing within the apartment interior certainly would have been quicker and less expensive than the destructive testing that was carried out at the building’s courtyard plaza waterproofing system in a futile search for an exterior source of the excess moisture.
