USING GPS TECHNOLOGY AND WEB IMAGERY IN ROOF CONSULTING

BY REMO CAPOLINO, RRC, PE

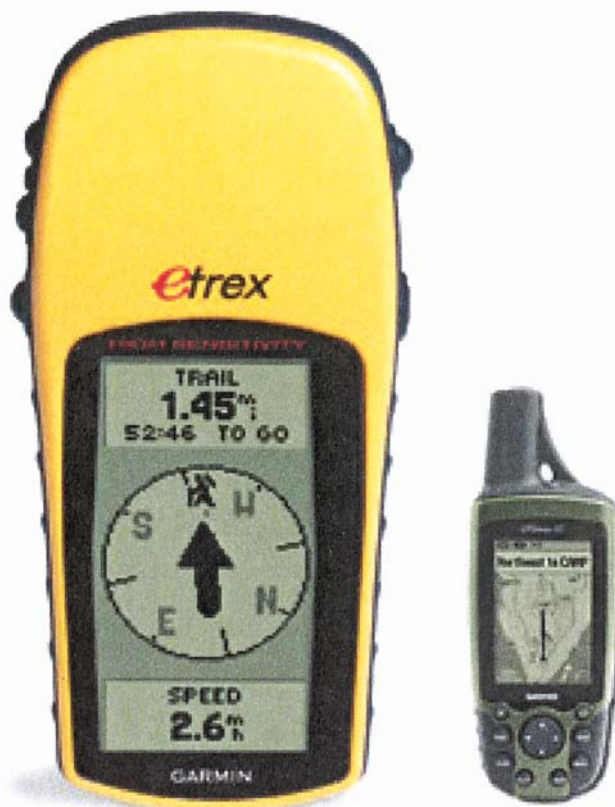
Photo 1 – Handheld GPS units.

used by hikers or other outdoor enthusiasts (Photo 1). The cost of this equipment was anywhere from \$200 to \$400. In-house testing revealed the latitudinal and longitudinal accuracy and repeatability to be about 16 ft. While this degree of accuracy may be acceptable for hiking – if trying to find a circle of orange paint on the roof indicating the presence of a pinhole-sized breach in the membrane, or if attempting to create a roof plan with over 100 of these locations – this degree of accuracy is not sufficiently precise.

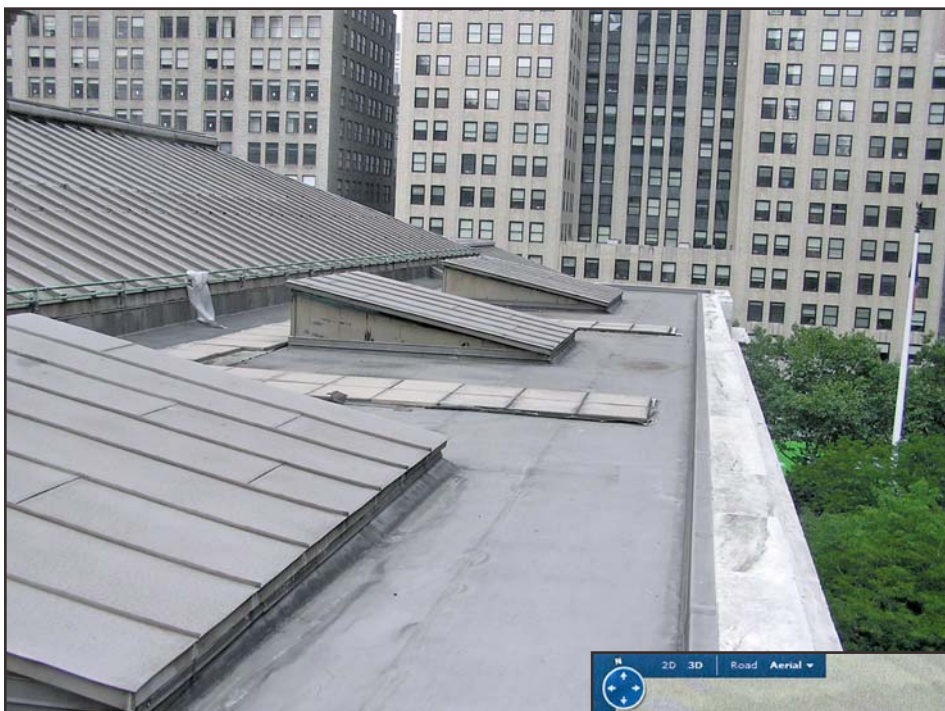
Photo 7 – Photo taken from the roof above the 5th Avenue entrance to the library.

The resolution of the imagery available for cities such as New York City is astounding. The roof above the 5th Avenue main entrance is shown in a screen capture of an aerial photo from Bing Maps in Photo 6. Photos taken from the roof, as well as one obtained from Bing Maps, are provided in Photos 7 and 8, respectively. The detail pro-

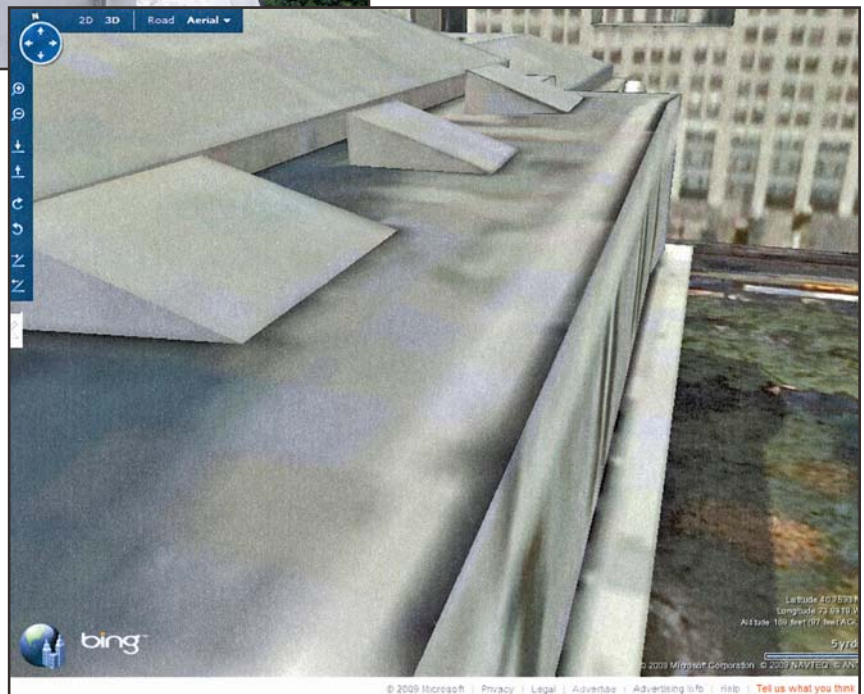
Photo 8 – Image from Bing Maps of the same location shown in Photo 7. Only the flagpole is missing!

vided from the available Internet imagery is astonishing and can provide relatively accurate elevation information that can be used to determine the pitch of the sloped-roof areas shown in the photos. The resolution does vary, depending upon the location. As one might expect, metropolitan areas such as New York City and Boston have better resolution than rural locations; however, consultants may be surprised with the resolution of areas such as central Kansas and find the information very useful prior to a site visit.

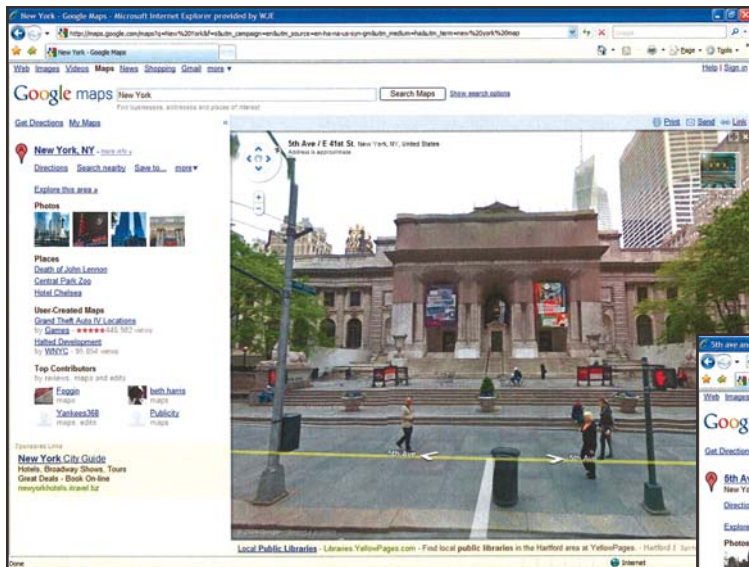
Photo 9 – Street-view photo from Google Maps.

entrance elevation (Photo 9) and a zoomed-in photo of the center entry door (Photo 10), when compared to the very detailed drawings available of the building (Photo 11).
