# WATERPROOFING IS NOT BELOW-GRADE ROOFING

By David Campbell, RWC, AIA

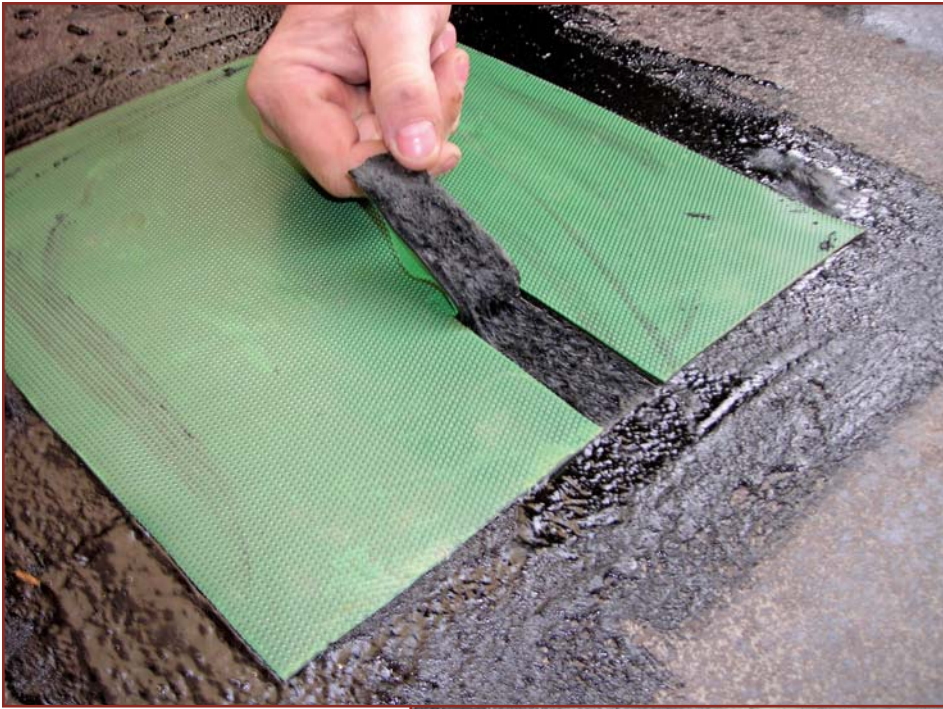
Photo 4

*Photo 4* shows one method of testing the

adhesion of a hot, fluid-applied, rubberized asphalt membrane. The adhesion test reveals adequate bond by virtue of the fact that the rubberized asphalt separated from itself rather than separating from the substrate. *Photo 5* shows the same type of waterproofing membrane completely debonding from the substrate due to a combination of excessive primer and an extremely smooth substrate surface. *Photo 6* shows the type of debonding that can occur when a cold, fluid-applied membrane is incompatible with the liquid curing agent that was applied to the substrate.

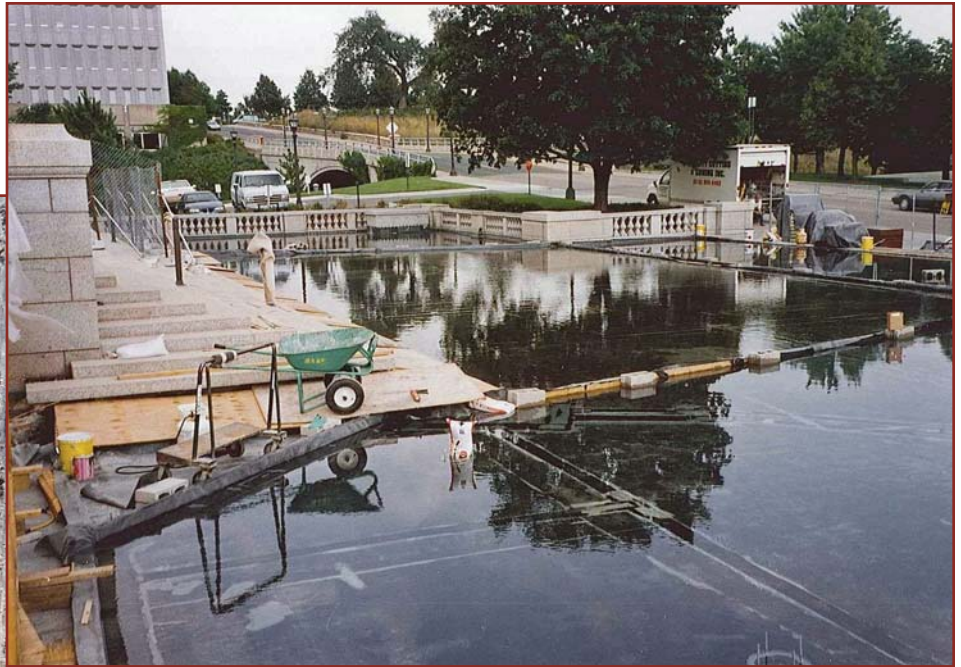
Photo 7

Testing the substrate for moisture content is also critical. *Photo 7* shows what can happen when hot rubberized asphalt is applied to a concrete substrate that has too high a moisture content. The moisture in the concrete vaporizes when the hot, 375-degree material hits it, creating water-filled blisters, which can break open and cause membrane failure.
