REASONABLE INTENTIONS AND INSTALLATION TEMPERATURES; *A CAUTIONARY TALE*

BY JEFF CRAMER, RRC

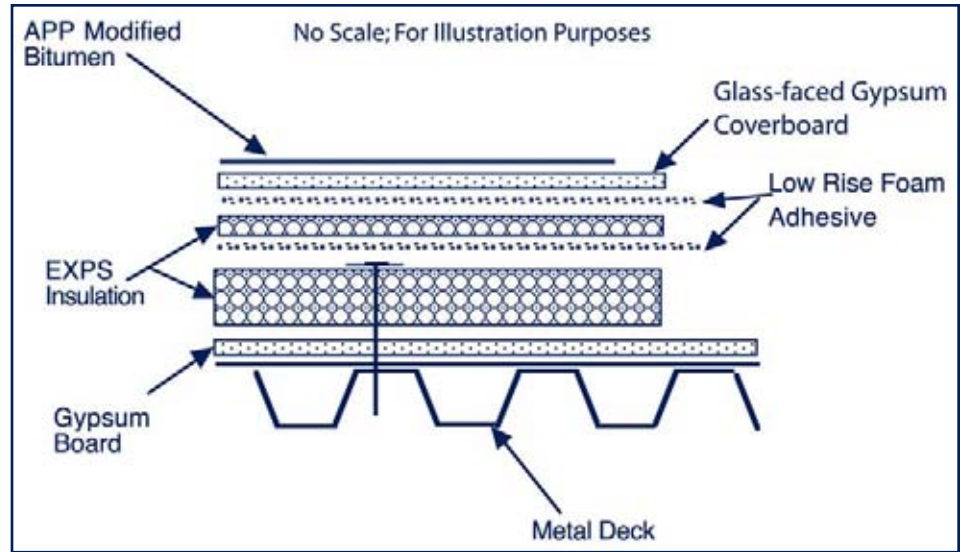
The words "lift" or "warp" do not adequately describe the condition of the insulation. It was curled similarly to potato chips. The curling was so pronounced that the deformation dislodged the 1/2-inch, glass-faced gypsum coverboard that had been

installed with low-rise foam adhesive. Its movement in one location had pulled apart torched-down, modified-bitumen side laps.

The only variable was the black polyethylene sheeting laid over the roof to keep its surface moisture-free. This appears to have prevented the dispersion of solar-generated heat, and thus, allowed the tapered insulation to reach temperatures in excess of the recommended service temperature.
