# SURVIVING NATURE'S FURY:

## PERFORMANCE OF ASPHALT SHINGLE ROOFS IN THE REAL WORLD

By Zhuzhao Liu, Hank Pogorzelski, Forrest Masters, Scott Tezak, and Timothy Reinhold

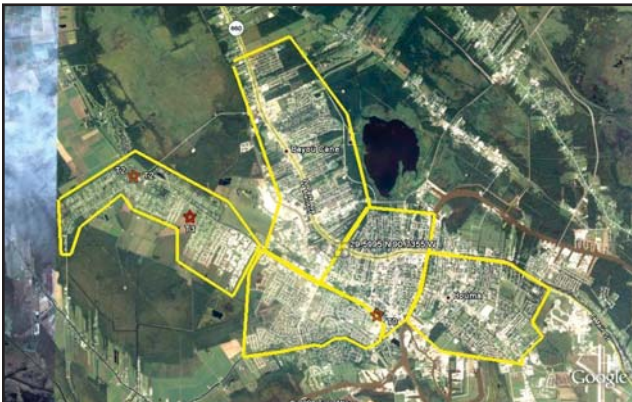
total of 933 houses spread among the five yellow areas of Houma shown in Figure 3. The information collected included address, type of roof cover, roof shape, roof pitch, wall type, and estimated average amount of roof damage as a percentage of the visible roof area. The data on the extent of the roof cover damage were generally recorded in 5% increments of the visible roof-surface area.

Figure 3 — Area division of field investigation of roof cover damage in Houma, LA.

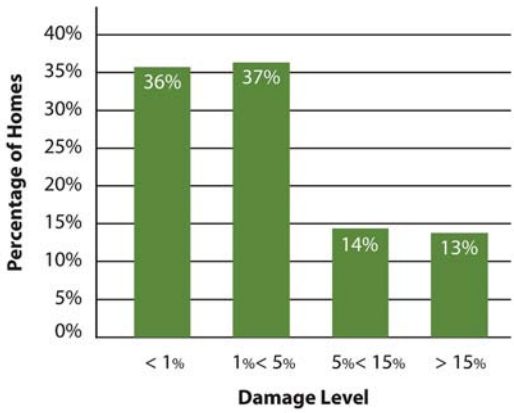
Summary data for damage frequency and severity obtained from the ground survey are listed in Table 2 and shown in Figure 4. Of the 933 houses investigat-

ed, 602 (65%) suffered some level of roof cover damage. The average roof cover damage per home was 7.7%. Of the 602 homes with roof cover damage, the average roof cover damage was 11.9%.

Figure 4 — Distributions of damage severity for homes with roof cover damage.

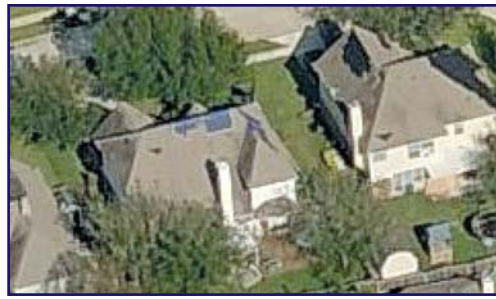
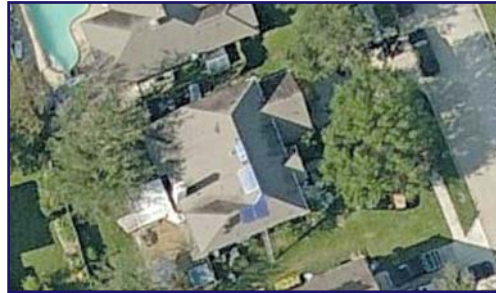
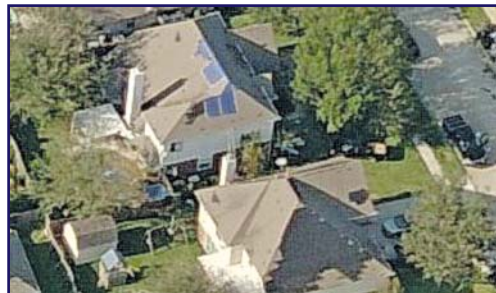
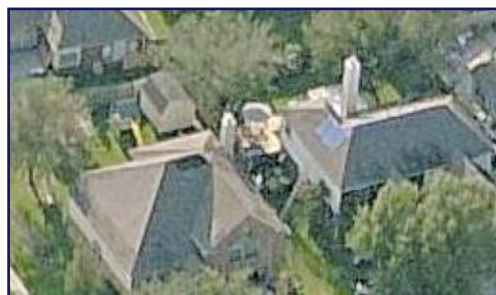
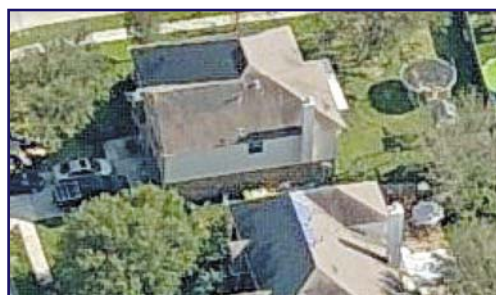
Figure 7 — High-definition aerial photographs provided by FEMA/Pictometry International Corp.

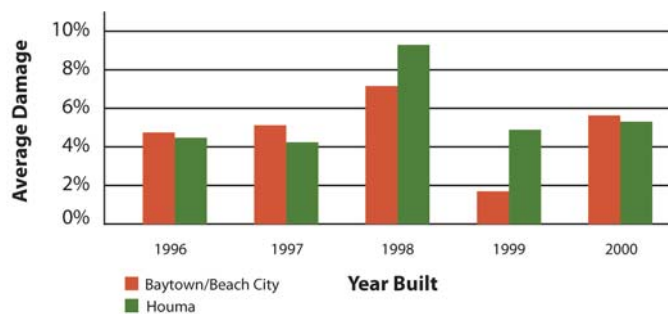
When one compares homes of the same age, the average damage per exposure for homes in the Houma data set is similar to that of the combined Baytown and Beach City data sets. This is illustrated in Figure 8.

Figure 8 — Average damage by age and location of homes.

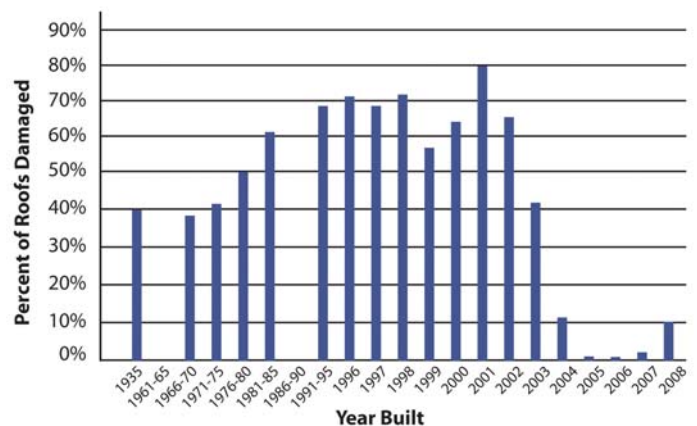
Figure 9 — Roof cover damage rate by the year of construction.

Figure 9 presents the entire data set, including homes constructed after 2000 (for which there are no homes in Houma) and homes built prior to 1996 (for which there are no homes in Baytown or Beach City). Additionally, the data set contains no homes constructed from 1986 to 1990 and only three homes constructed from 1961 to

The analysis showed a significant decline in the damage rate beginning with homes constructed in 2002 and later. By 2005, the decline reached the point where very few homes built in 2005 or later experienced any observable level of roof cover damage. The damage rate also gradually declines with increasing age for homes built prior to 1996. This trend may be a result of the roof replacement rate on some older homes beginning in 1991 and increasing with each successive set of older homes.

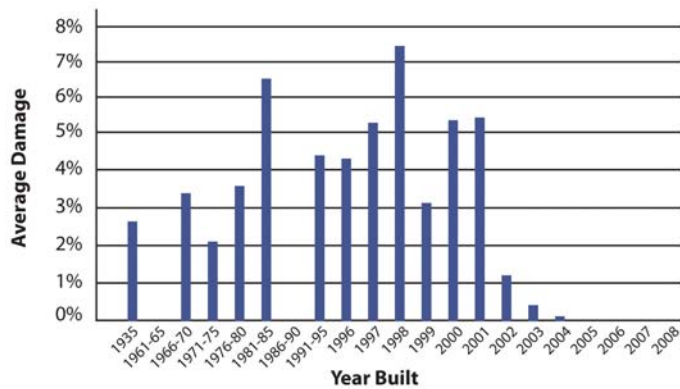
Figure 10 — Average damage area as a percentage of total roof area by year of construction.

Average areas of roof cover damage by year of construction are presented in Figure 10. The damage area percentage is based on all homes in the data set, including those with no damage.

Two factors appear to have been involved in the sharp decline in the average damage sustained by houses built in 2002 and later in Baytown and Beach City. These newer homes received an average of just 0.3% damage compared to the average of 4.9% damage for all older homes in this area. This may be due to limited exposure to the aging effects of weather, but the homes also may have benefited from the strengthening of building code requirements that

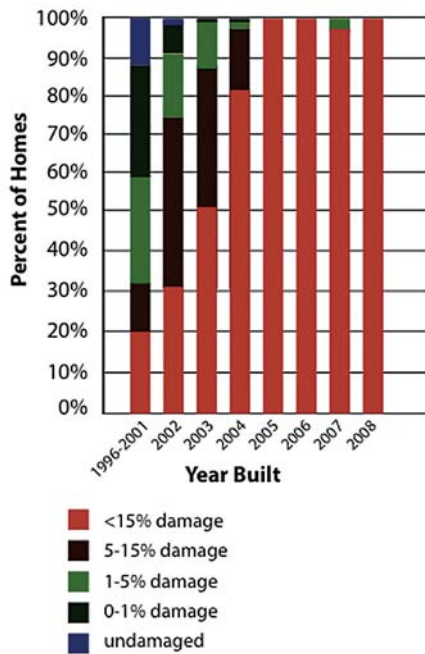
Figure 11 — Average damage by year in Houma data set.

Figure 11, the graph depicting average roof damage, shows that the clearest pattern of damage increasing with age occurs in homes constructed from 1998 to 2008. The newest homes (those constructed between 2005 and 2008) sustained almost no damage. Average damage per exposure increases modestly with age, beginning with homes constructed in 2004 and continuing through homes constructed in 2002. This is followed by a large increase in damage for older homes, beginning with those constructed in 2001 and peaking in homes constructed in 1998.

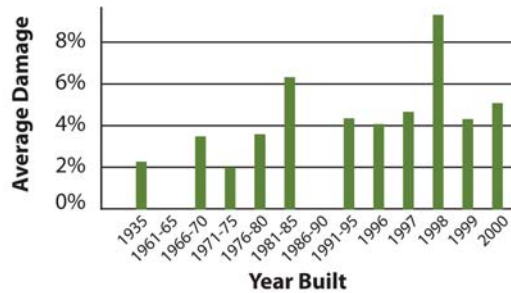
Figure 12 shows the average damage by year in the Houma data set, which contained no homes constructed after 2000. This data set shows no pattern of increasing damage with age. In fact, average damage per

Figure 12 — Average damage by year in the Houma data set.

exposure tends to decrease slightly with age, likely due to the fact that the age of the homes in Houma is no longer a reliable proxy for the age of the roof.

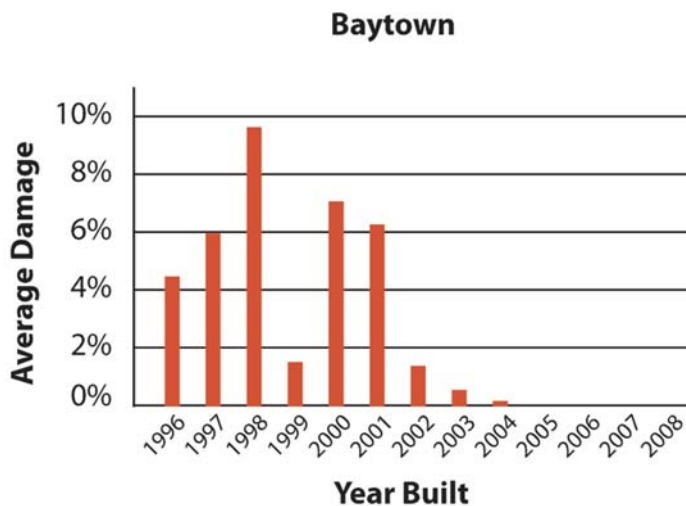
The age of the homes in this study that were affected by Hurricane Ike in Texas ranges from one to 12 years, and therefore the age of the home is more likely to reflect the age of the roof. Figures 13 and 14 represent the average damage per exposure by year individually for the Baytown and Beach City communities. Each graph shows a sudden increase in average damage for homes constructed in 2001, followed by a general trend of increasing damage for homes built in prior years.

One interesting trend was that the average damage per exposure peaks for Baytown homes built in 1998, but declines for those constructed in 1997 and 1996. Aerial photography analysis showed this decline may be due more to the location of the homes and the density of the tree cover surrounding them than to their age. These homes are located at the west side of the community and are surrounded by other houses and high-density woods that may

Figure 13 — Average damage by year in Baytown.

have shielded them from the higher winds.

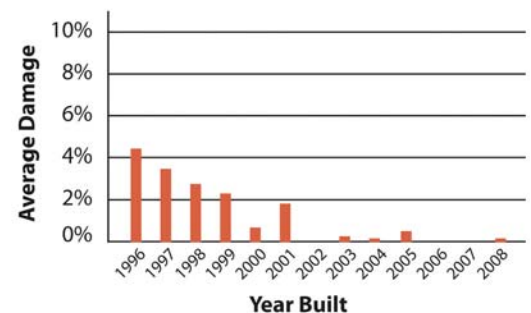
Figure 14 — Average damage by year in Beach City.

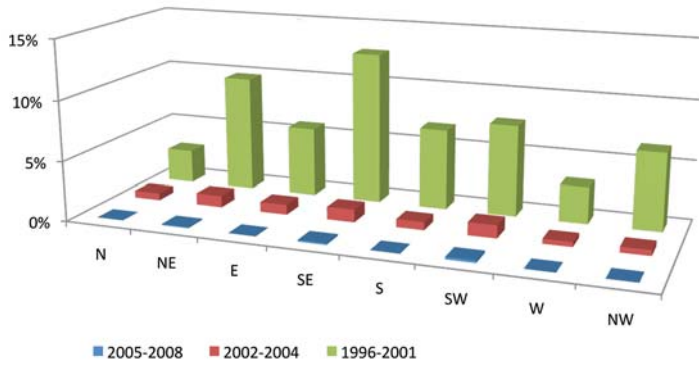
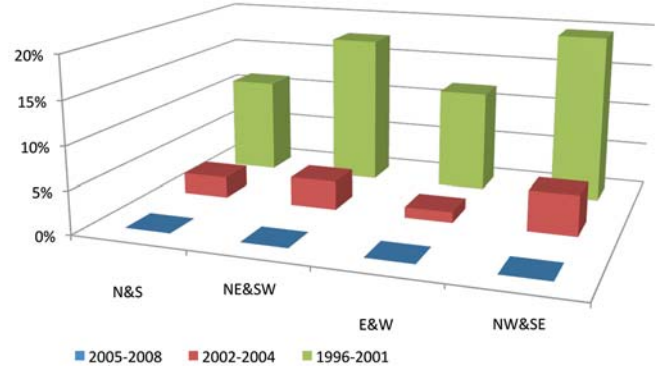
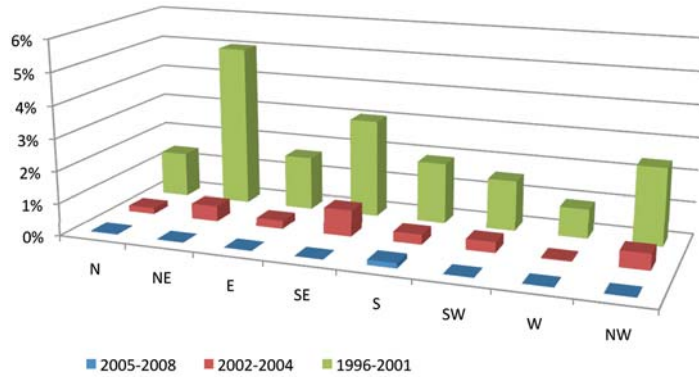
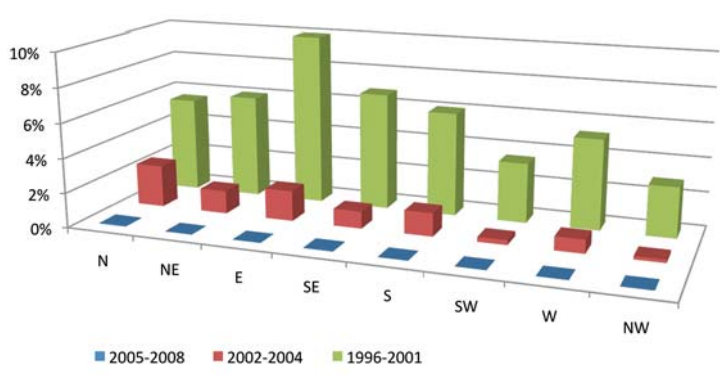
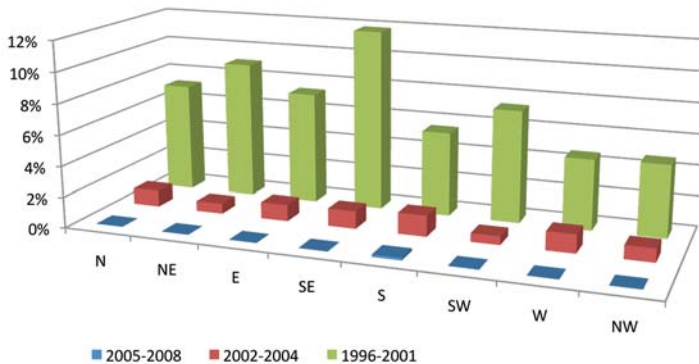
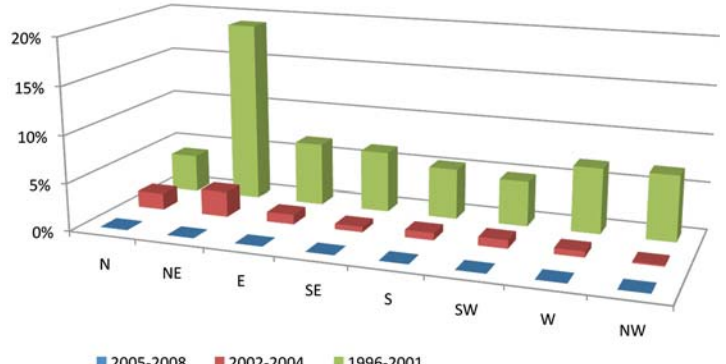
The Baytown data set was divided into three groups based on year of construction: homes built in 2005 or later, homes built from 2002 to 2004, and homes built prior to 2001. The average damage on different roof areas of each group was calculated for eight directions, and results are shown in Figure 15. The high wind speeds recorded by mobile towers in Hurricane Ike for Baytown homes were concentrated at east-northeasterly and south-southwesterly directions. While damage was observed on nearly all roof surfaces for older homes, the average damage on roof areas facing the incident wind directions is higher than for other roof areas. The distributions and damages observed clearly demonstrate that roofs on older homes were more sensitive to wind direction than roofs on newer homes.

Figure 15 — Average damage on different roof areas of Baytown homes.

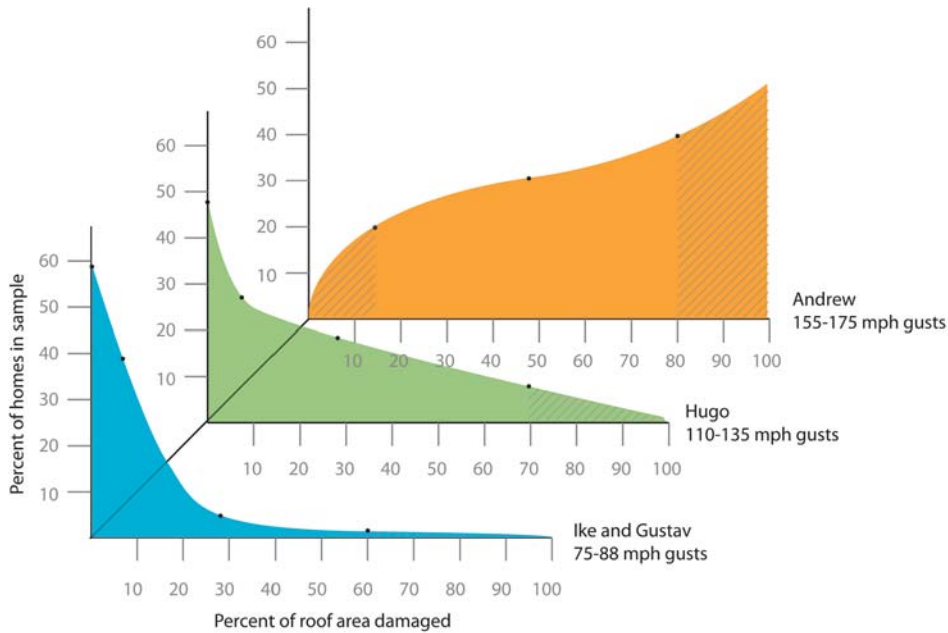
The analysis of damage presented in this study used a fairly fine breakdown of damage levels into smaller area increments, in part, because the winds were relatively low. The change in roof damage area statistics associated with increased wind speeds is illustrated in Figure 16.

Figure 16 — Simplified illustration of the variation in roof cover damage vs. gust wind speed.
