ELECTRIC FIELD VECTOR MAPPING (EFVM)

By Chris Eichhorn, RRO

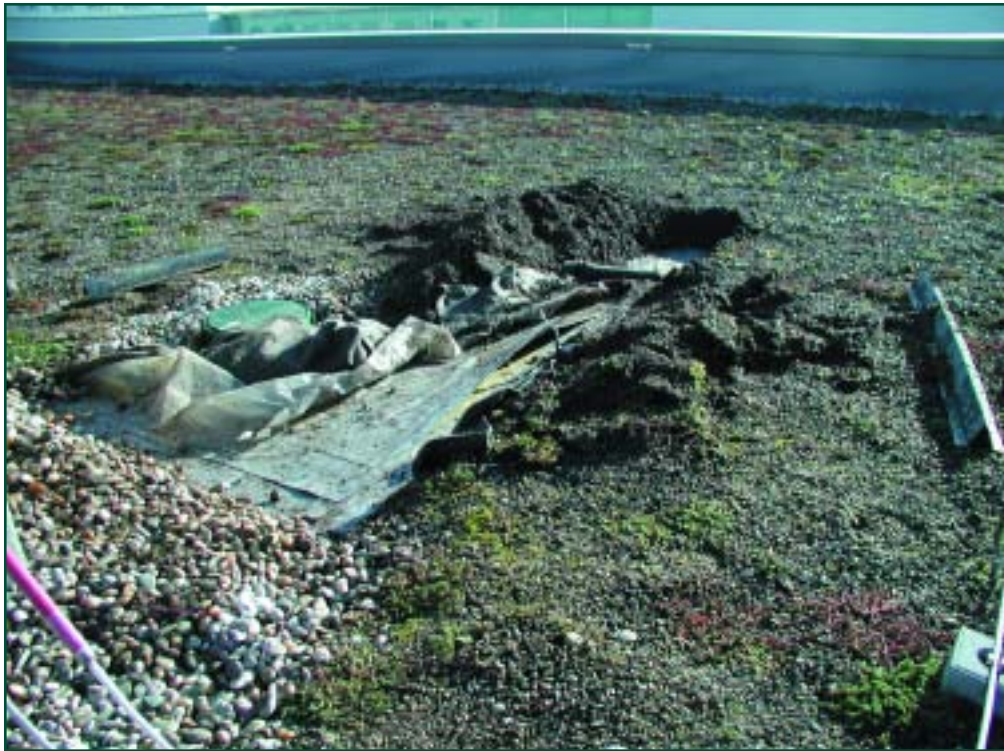
Figure 2: Leak investigation on a green roof in Frankfurt, Germany.

A recent project in Frankfurt, Germany, further illustrates the value of EFVM as an asset management technique. This project involved an 110,000 square foot roof that was installed in 2000. The technicians found 17 defects in the membrane. Some of these flaws were located in defective seams (workmanship) while others were found to be tiny punctures. There was no visible water damage in the interior of the building. The building owners did not know that there were any problems and probably would not have found the flaws until the insulation had become saturated.

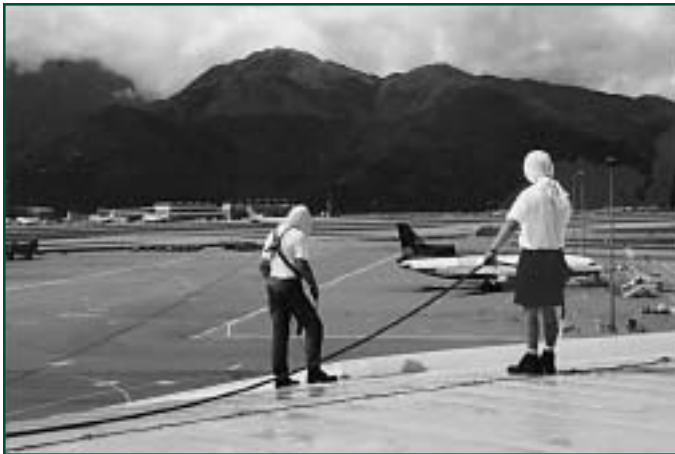
Figure 3: Leak detection at Chek Lap Kok airport, Hong Kong. Applying continuous flow of water on the sloped PVC membrane to facilitate the test.

EVFM was used as a quality control measure at the Chek Lap Kok Airport in Hong Kong. A total of 165,000 square feet was electronically surveyed, and over 100 breaches were located in the membrane. The contractor was still on site at the time of the testing and repaired the breaches on a daily basis. The repaired areas were tested upon completion by the survey technicians to ensure the membrane was 100% watertight. A new addition, presently at the developmental stage, will include the EFVM test as part of the specifications.

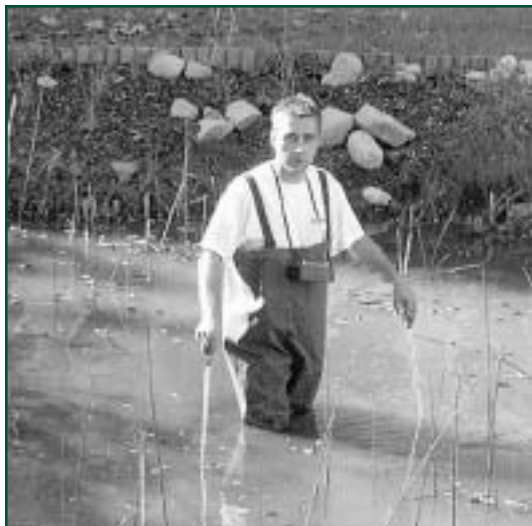
Figure 4: Locating leaks in a geo-membrane liner with the EFVM technique.

Geo-membrane liners and/or containment liners are also beneficiaries of the EFVM test. These membranes can be tested for any defects prior to commissioning their use and, depending on the depth of the containment basins, also during their use.

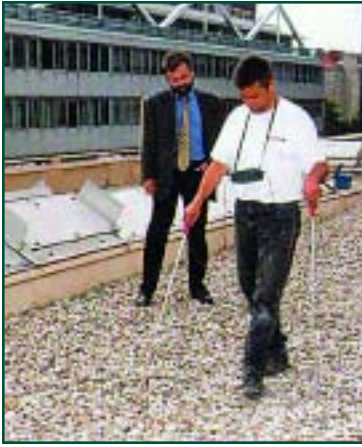
Figure 5: Leak detection procedure on an inverted BUR roof system. Locating breach through the ballast and insulation.

The EFVM method has proven highly advantageous in situations where the waterproofing is concealed or buried. These include IRMA (Inverted Roof Membrane Assembly) configurations, plaza installations, ballasted roofs, and "green roofs." Green roofs are veneer landscapes installed on top of conventional roofs. They may be anywhere from 2.5 inches to 3 feet deep.
