The Application of Spray Polyurethane Foam and Elastomeric Coatings for Repair and Maintenance of Bituminous Roof Systems

By Robb G. Smith, RRO, FRCI, RRC, and Dan Varvais

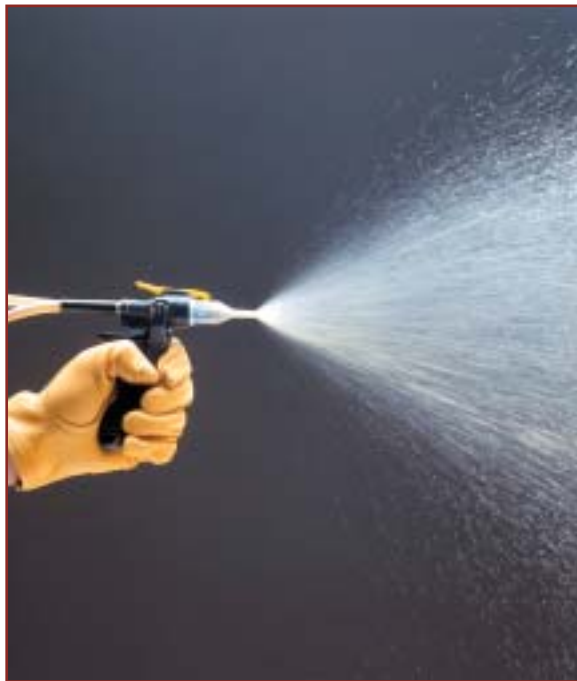
SPF gun and foam from a portable foam kit.

The efficient and economical maintenance alternative to the above is found in 39-lb. cartons containing the "A" and "B" materials with disposable spray guns and nozzles. These are ideal for the application of SPF for small roof maintenance projects, repairing burned-out curb and wall flashing, and sealing pitch pans and new penetrations.

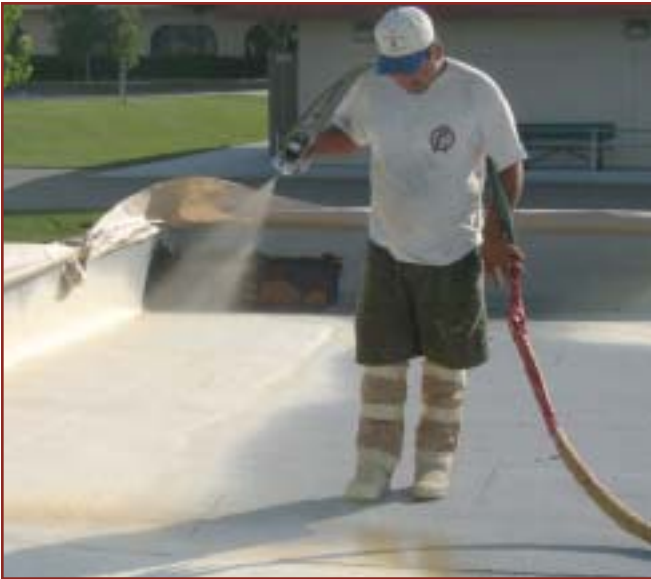
Application of SPF from trailer-mounted spray rig.

Most SPF roofing is applied by contractors who have a 30 kW generator, a material and hose metering unit with heater, and high pressure 45:1 hydraulic pumps, all contained within a large, truck-mounted van or fifth wheel trailer. These types of rigs are necessary to supply large volumes of material when completing entire roof restoration projects or when applying entire new SPF roofs. Alternative systems are available for smaller maintenance projects.

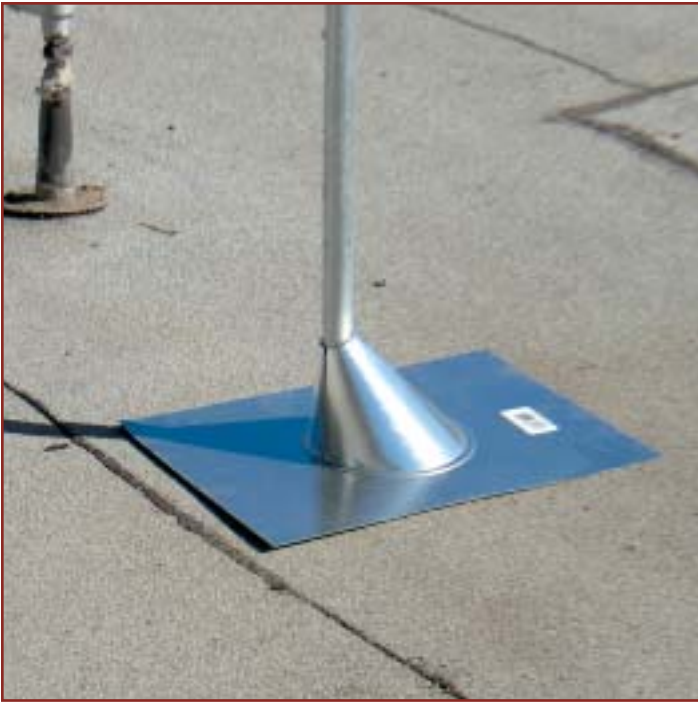
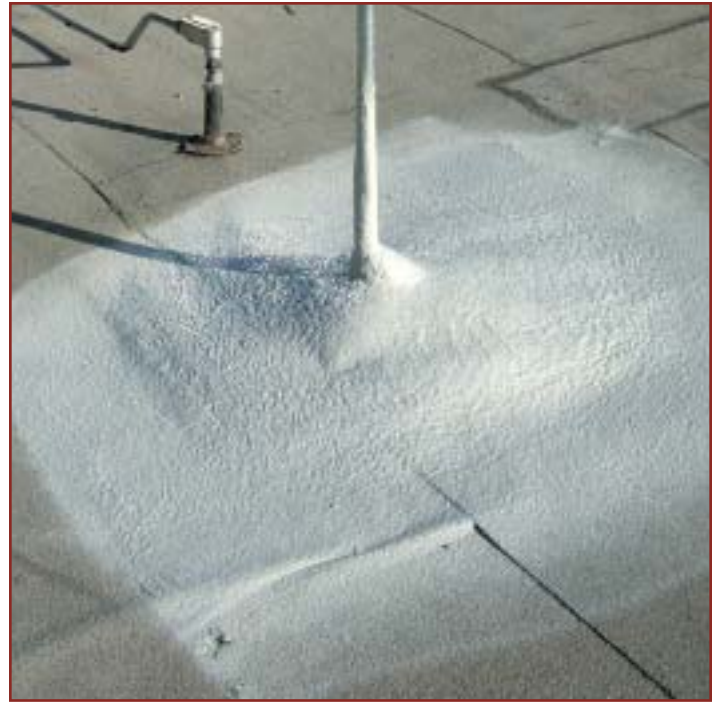
New conduit penetrations.

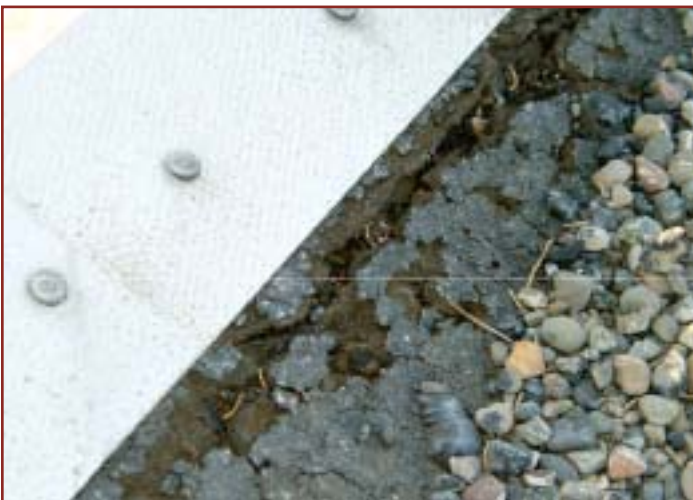
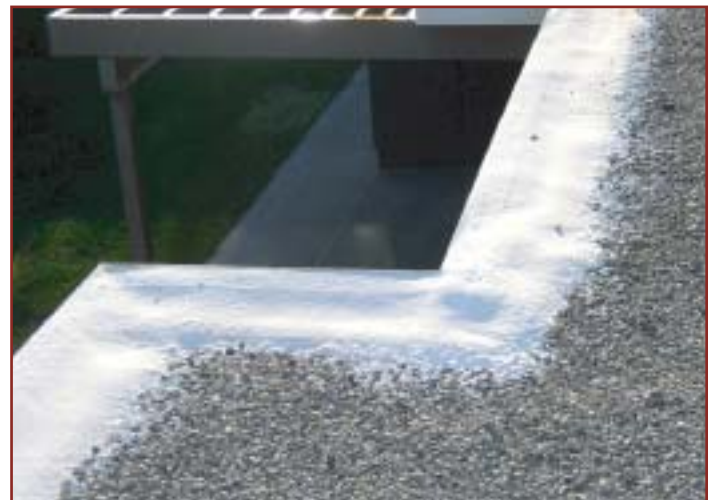
Raised edge flashing repair, before (left) and after (right).

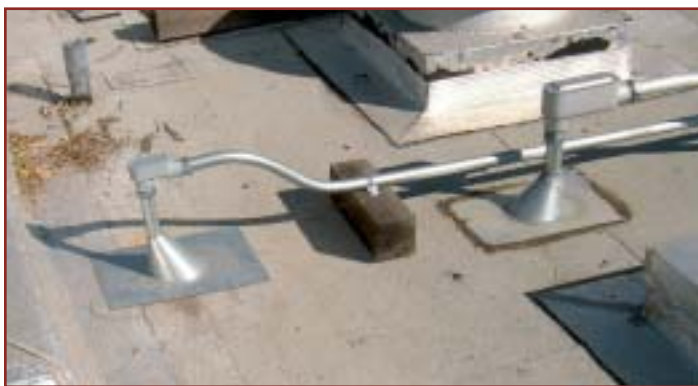
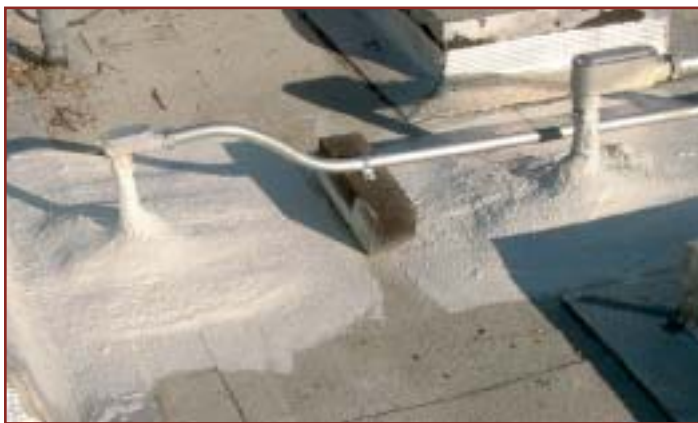
New conduit penetrations.

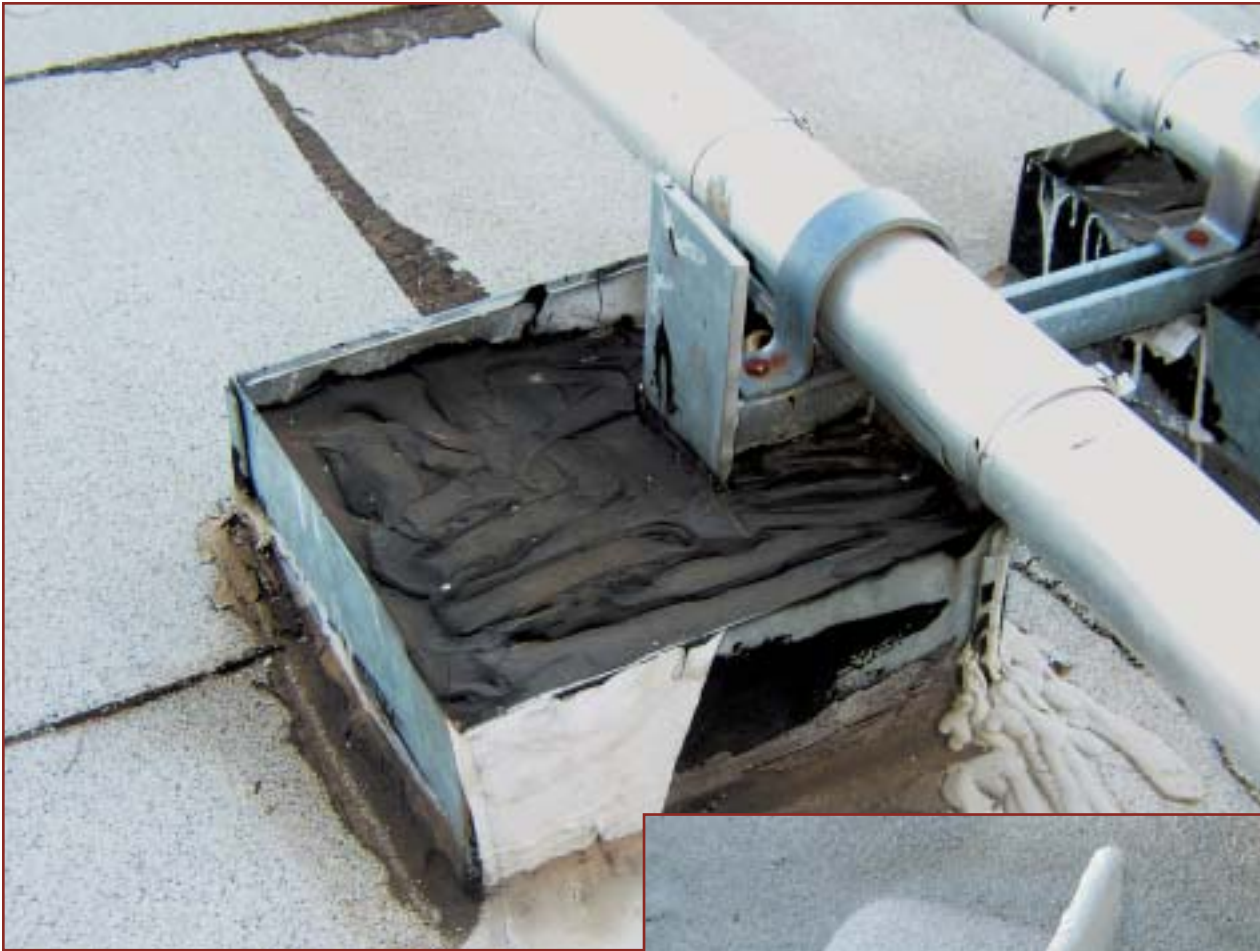
Old pitch pan with dried asphalt mastic.

loses volatiles, it shrinks in mass, leaving gaps between metal components it is supposed to be sealing. Coal tar evaporates during the aging process, but the net result is the same – loss in volume results in gaps between the metal and the bitumen.

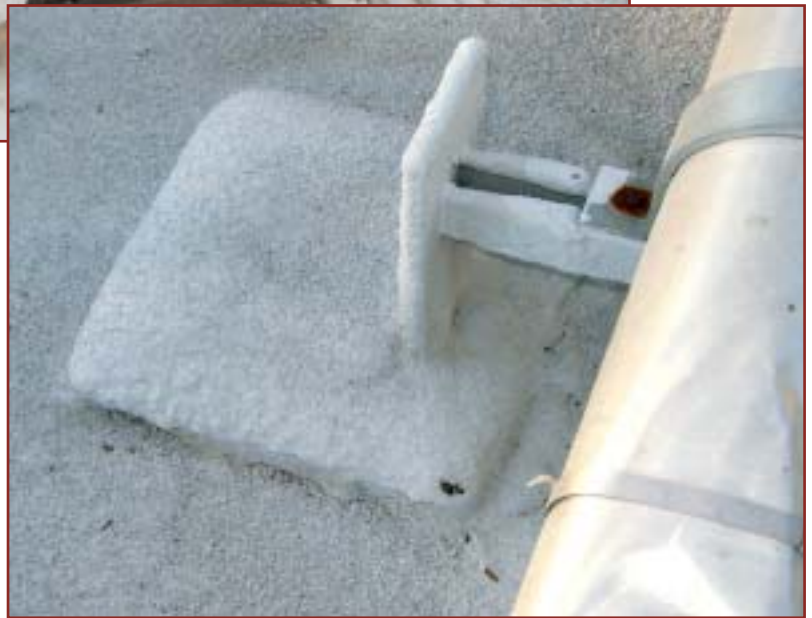
SPF and acrylic coating with ceramic granules, used to seal the pitch pan in the photo at the top.

After the foam is applied and smoothed as necessary, the SPF surface and six inches of the surrounding roof surface should be sealed with a roof coating. The most common coatings for this purpose are formulated from acrylic polymers, though polyurethane and silicone coatings are also widely used. Acrylic exterior house paint will not provide the necessary performance characteristics to survive in this application long term as compared to a quality roof coating. Application by airless spray gun is efficient for a large quantity of repairs; however, painting the coating on by brush or roller is also acceptable for smaller projects and is frequently more efficient. Two coats are recommended to achieve the minimum 25-mil thickness.
