Daytime Infrared Roof Inspections

(You **CAN** Get a Good Night's Sleep!)

By Ronald D. Lucier

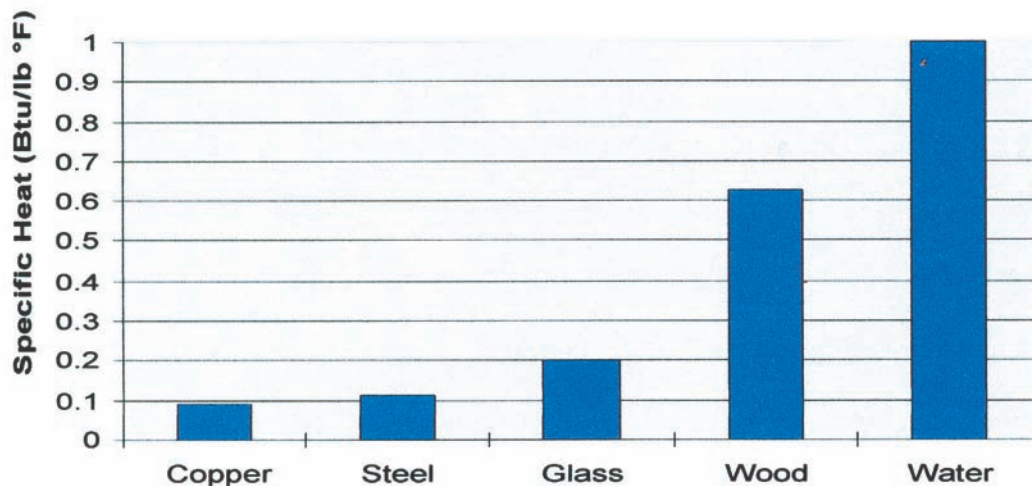
Figure 1

degree in temperature." The accompanying chart (Figure 1) provides a graphical representation of heat capacity of various materials. It is evident that water has the highest heat capacity (also known as "specific heat").

A careful interpretation of these data reveals that it takes over ten times as much heat to raise the temperature of water one degree as it does copper. Also, once the water has been heated, it remains warmer longer!

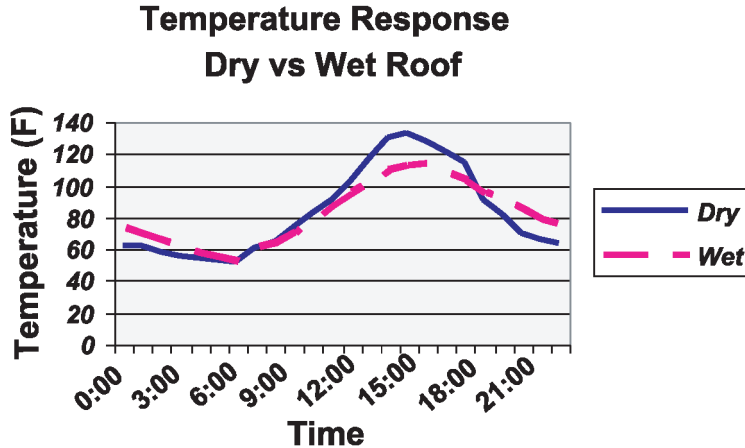
Figure 2

The net result of this is that when the sun radiates and warms the roof, the wet areas and dry areas heat at different rates. Similarly, at night, the wet and dry areas cool at different rates - graphically. See *Figure 2*.

It is evident from this representative graph that at two points

during a day, the wet and dry roof areas are at the same temperature; the infrared inspections would not be worth it. This may occur for two or three hours, depending on the weather and amount of solar insulation. However, for a significant part of the day, there exist significant temperature differences. These are the windows of opportunity in which to conduct the infrared inspections.

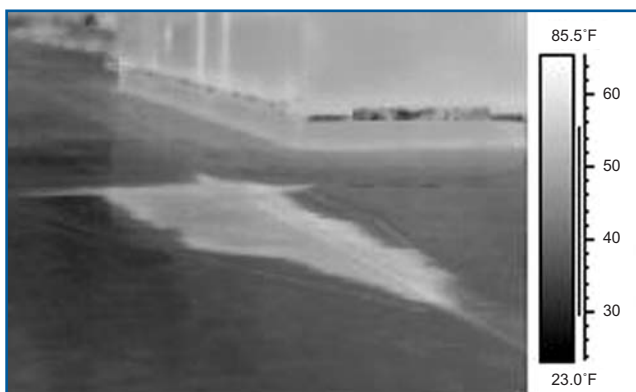
Photo 1: 9:54 PM

The daytime inspection process is very similar to one at night. On the rooftop, if it is inspectable (typically limited to adhered, unballasted membranes), the inspector systematically walks the roof looking for cooler areas typical of wet insulation (refer to the time vs. temperature chart). The two images in *Photo 1* and *Photo 2* present results the author located during the night and then during the day.

The images were taken at an electronics manufacturing facility from different perspectives, but the results are clear and easy to interpret. The temperature difference observed at night was 19°F, and 14°F during the day – very similar! Both were taken with a FLIR² P60 thermal imager on subsequent days. A follow-up core cut verified wet insulation.

One image looks like the negative of the other. During the night, the wet insulation was warmer than the dry insulation. This causes a temperature difference on the cap sheet (fully adhered). During the day, the wet insulation is heating up slower than the cap sheet, thus it looks (and really is!) cooler.
