IDENTIFYING BUILDING ENVELOPE PROBLEMS

BY MARK K. HOWELL

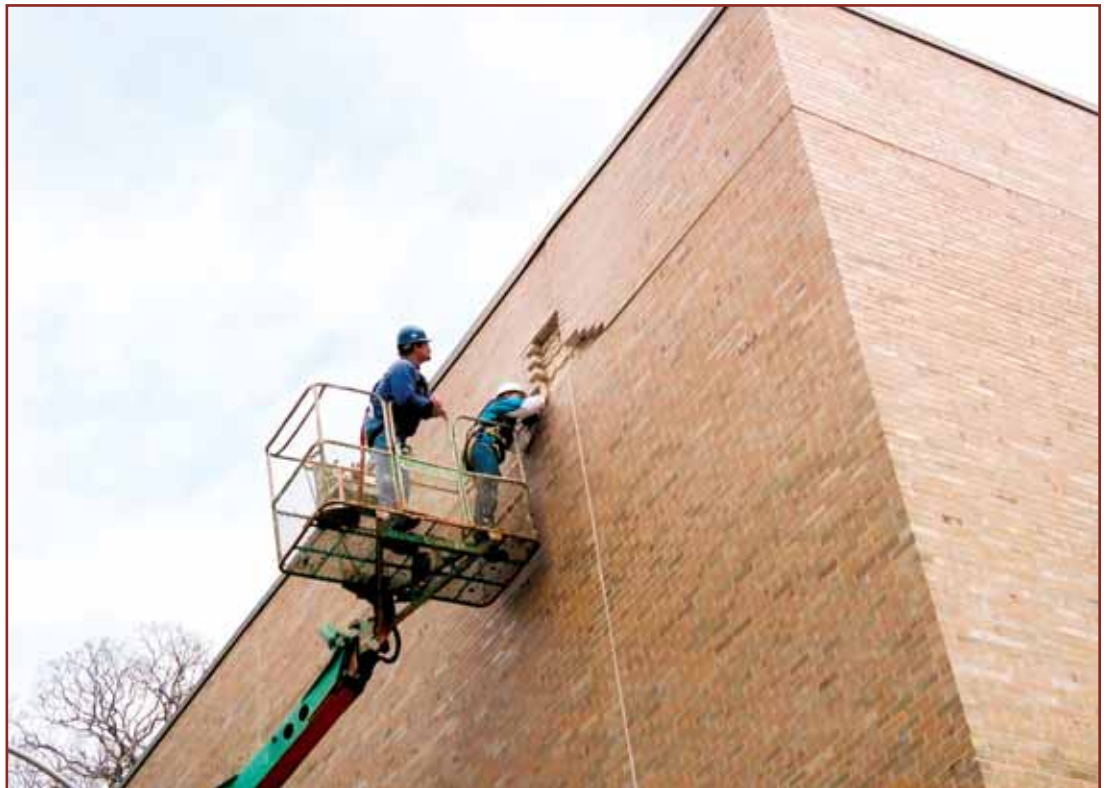
A masonry inspection opening

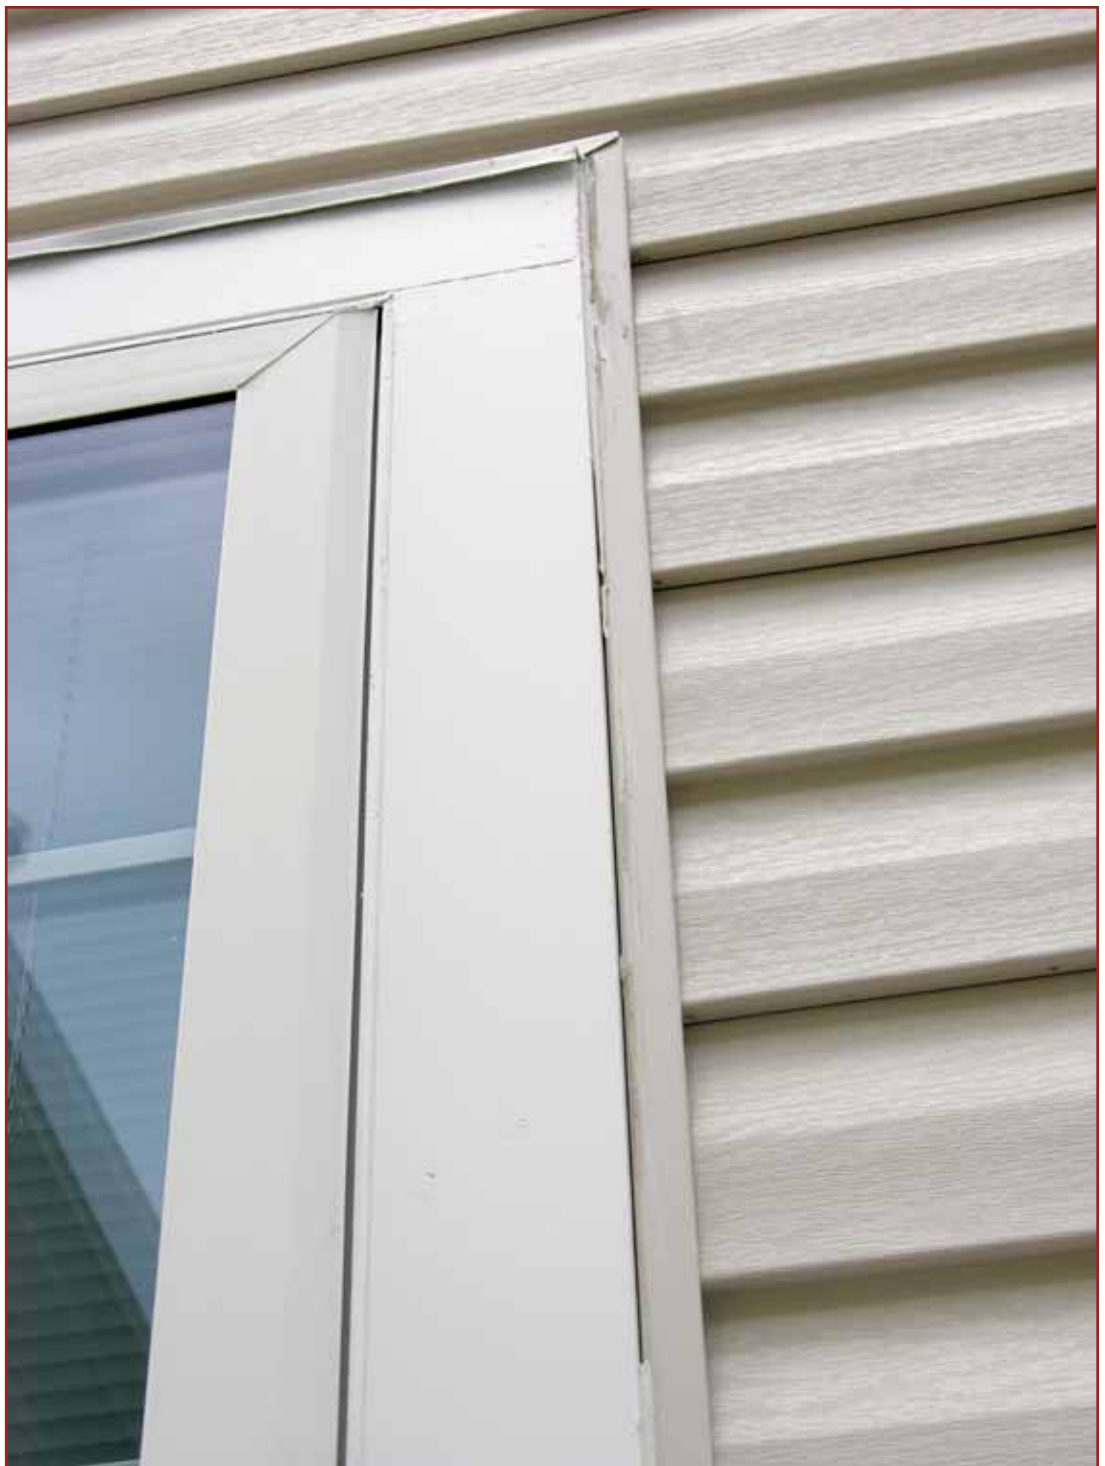
Sealant applied incorrectly at the window frame to trim and from trim to J bead

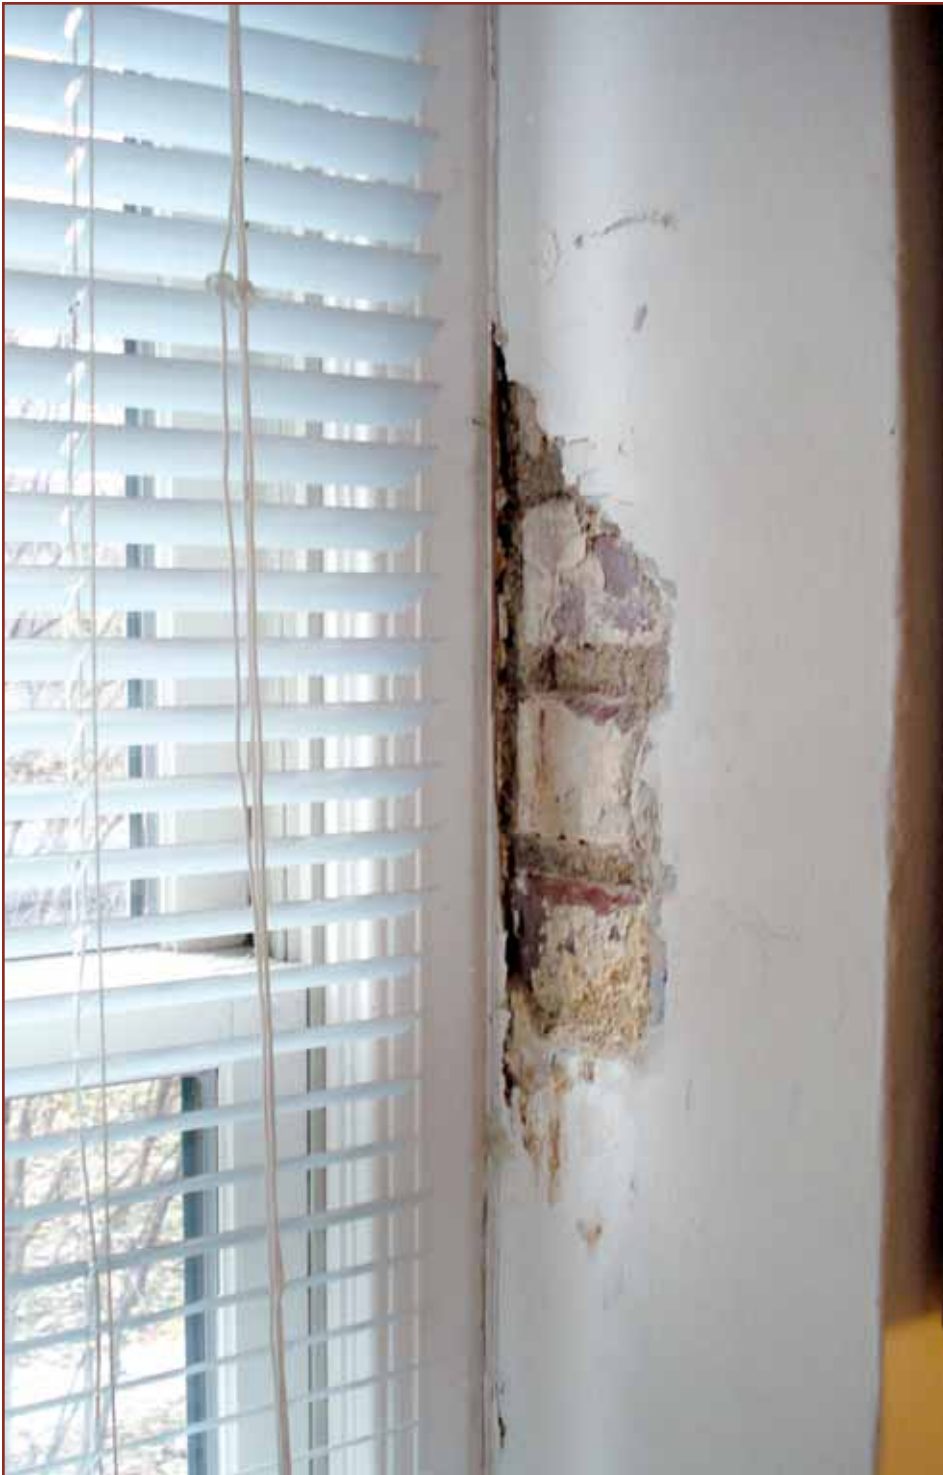
Interior damage at the jamb of a window

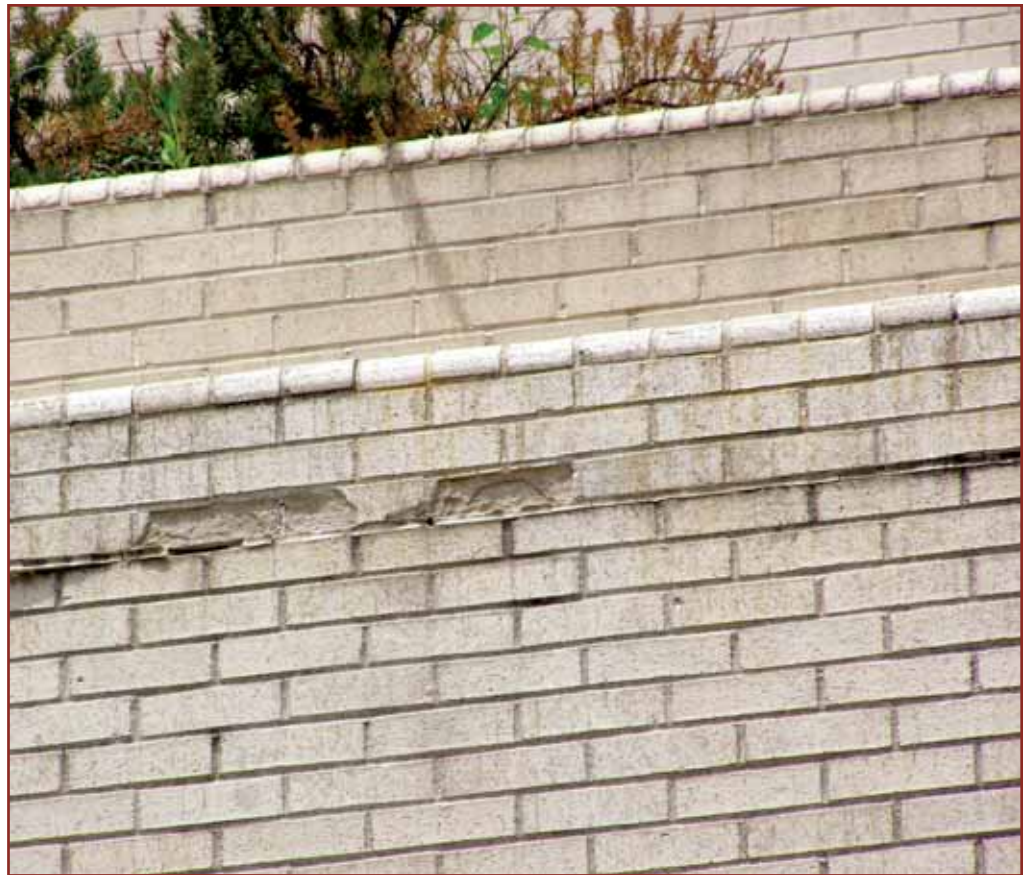
Exterior signs of brick spalling

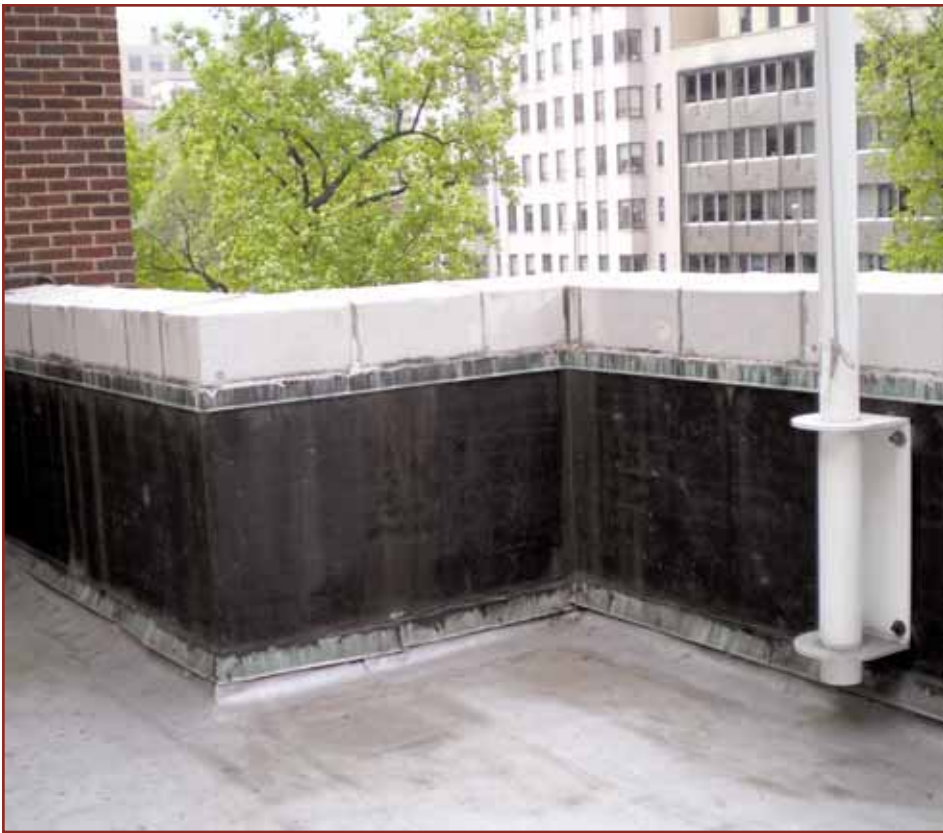
Roof run up the back of a parapet wall that created damage to the terra cotta cornice.

modification or repair? Also, if there has been a modification, what, if anything, has been done to the parapet wall? Because parapets are exposed to weather on three sides, there is a greater chance of their having problems, especially if the modifications did not take into consideration the original design intent. Identify the number of drains and whether there is an appropriate roof slope-to-drain. How the through-wall scuppers are detailed always should be reviewed, especially if the scupper outlet is directly at the vertical expansion joint. Finally, locate the system specified for the below-grade waterproofing and see if any details were made on termination, penetration, and changes in plane.
