NEW ROOFING SYSTEM HELPS PRESERVE HISTORIC NEW MEXICO BUILDING

After serving primarily as an unoccupied storage facility for nearly 15 years, the historic Lister Building in Lovington, NM, began its road to renovation in 2007. The cornerstone of the project was a new roofing system

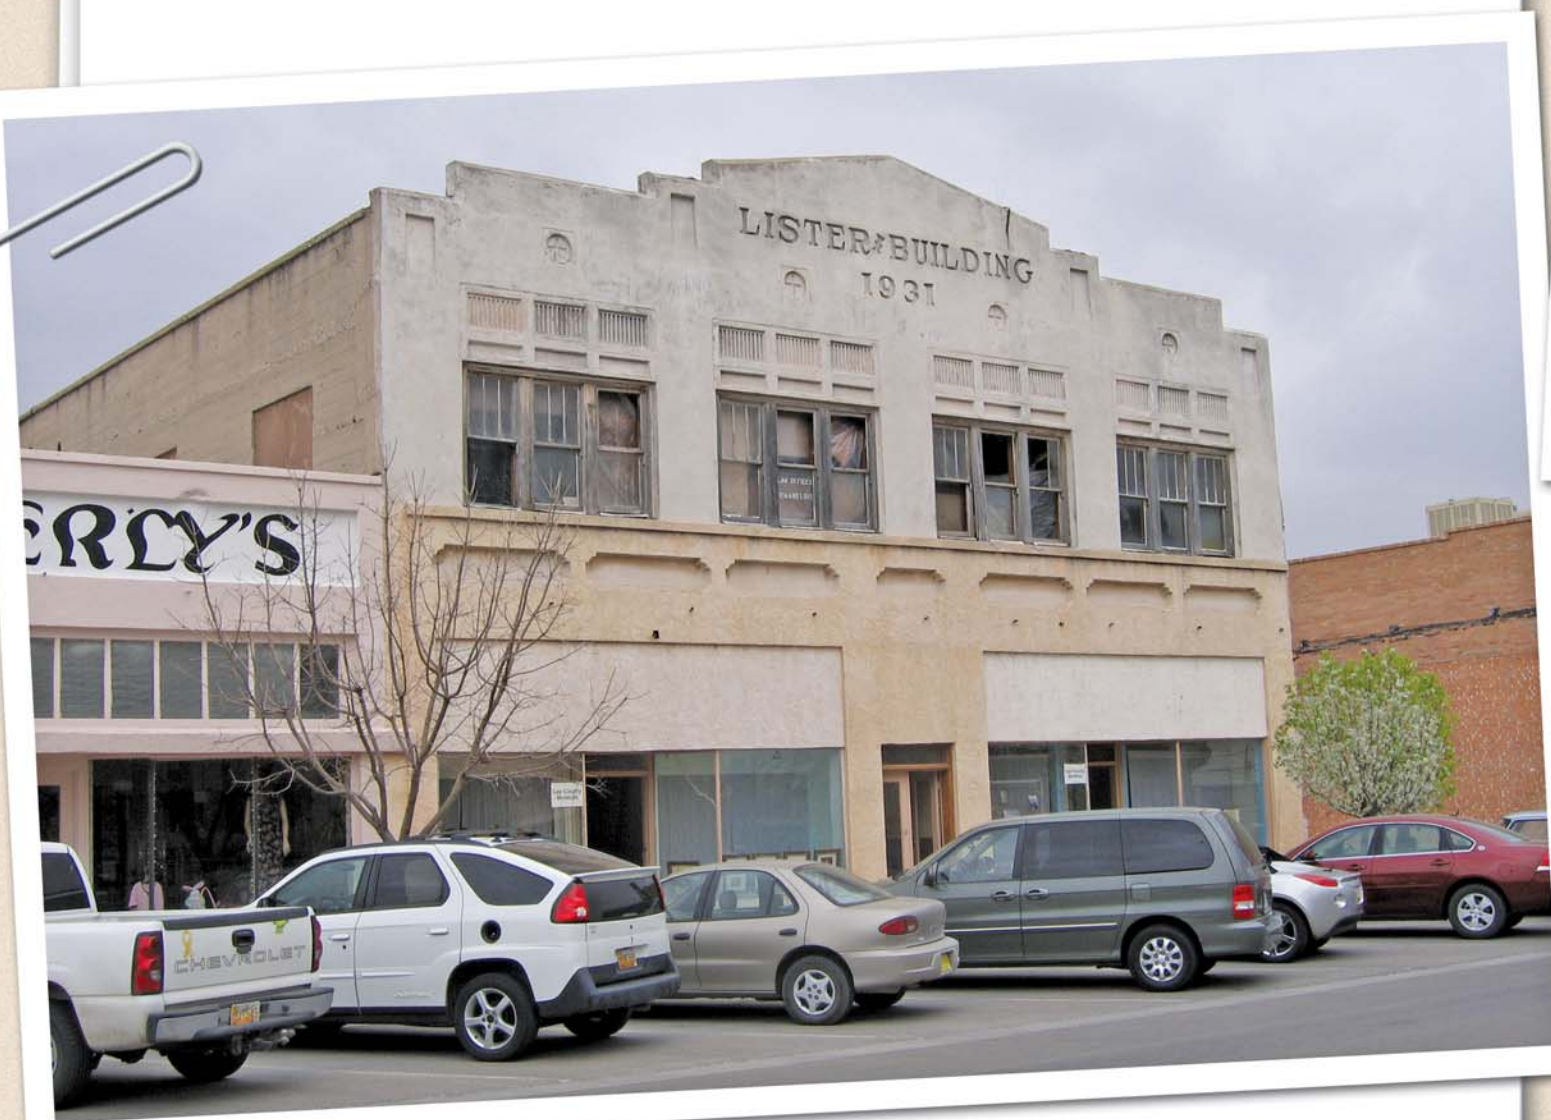
Built in 1931, the Lister Building in Lovington, NM, features a decorative façade that includes parapet walls ranging from 3 to 7 ft high.
